# **RAIN-INDUCED LANDSLIDE SUSCEPTIBILITY: A GUIDEBOOK FOR COMMUNITIES & NON-EXPERTS**

**A Guidebook for Communities and Non-Experts**

This guidebook offers a simplified susceptibility assessment of rain-induced, shallow-depth landslides. The assessment procedure takes off from the idea that the strength of the material or structure **S** should always be greater than the applied load or force **L** (**S**>**L**). This concept could be expressed as a factor commonly referred in engineering as Factor of Safety  $F_s = S/L$ , which should always be greater than 1. **Figure 1** below illustrates the concept:

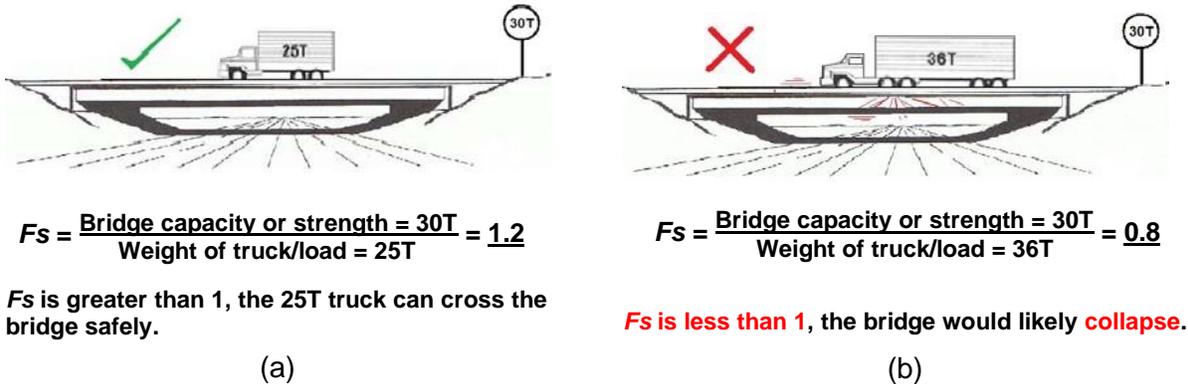
**Figure 1.** Factor of Safety  $F_s$  for a 30T-capacity bridge

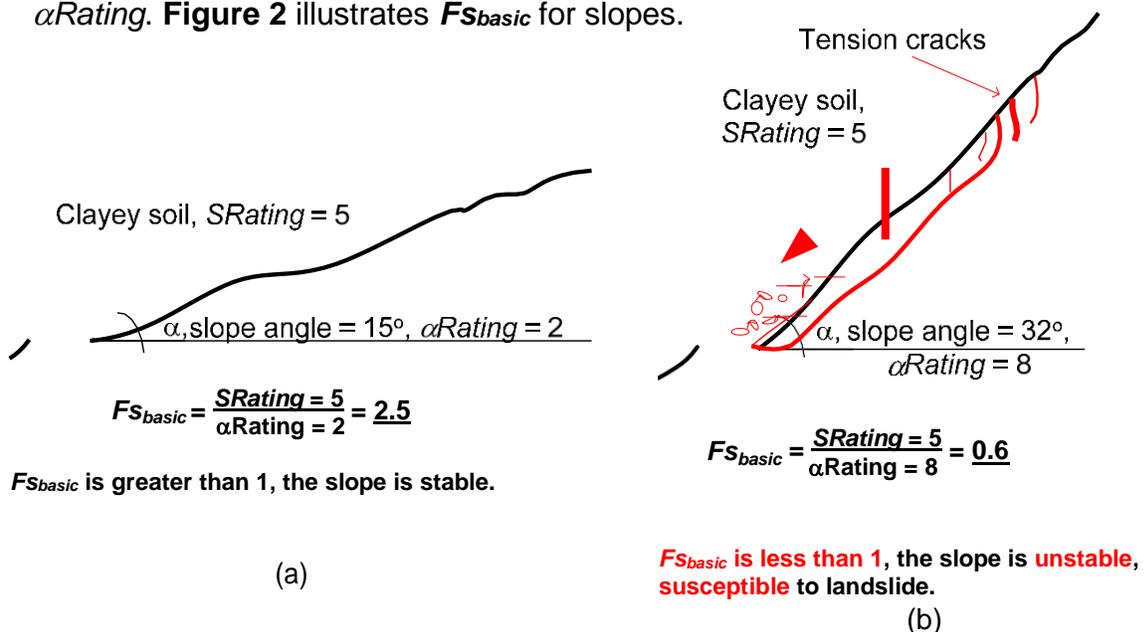
**Figure 2.** Basic Factor of Stability,  $F_{s_{basic}}$ , for slopes

where  $SRating$  is the strength rating or score of the slope material, while  $\alpha Rating$  is the rating for the slope angle  $\alpha$ . The main force driving landslides is gravity and is directly related to the slope angle  $\alpha$ ; the higher the slope angle  $\alpha$ , the higher the  $\alpha Rating$ . **Figure 2** illustrates  $F_{s_{basic}}$  for slopes.

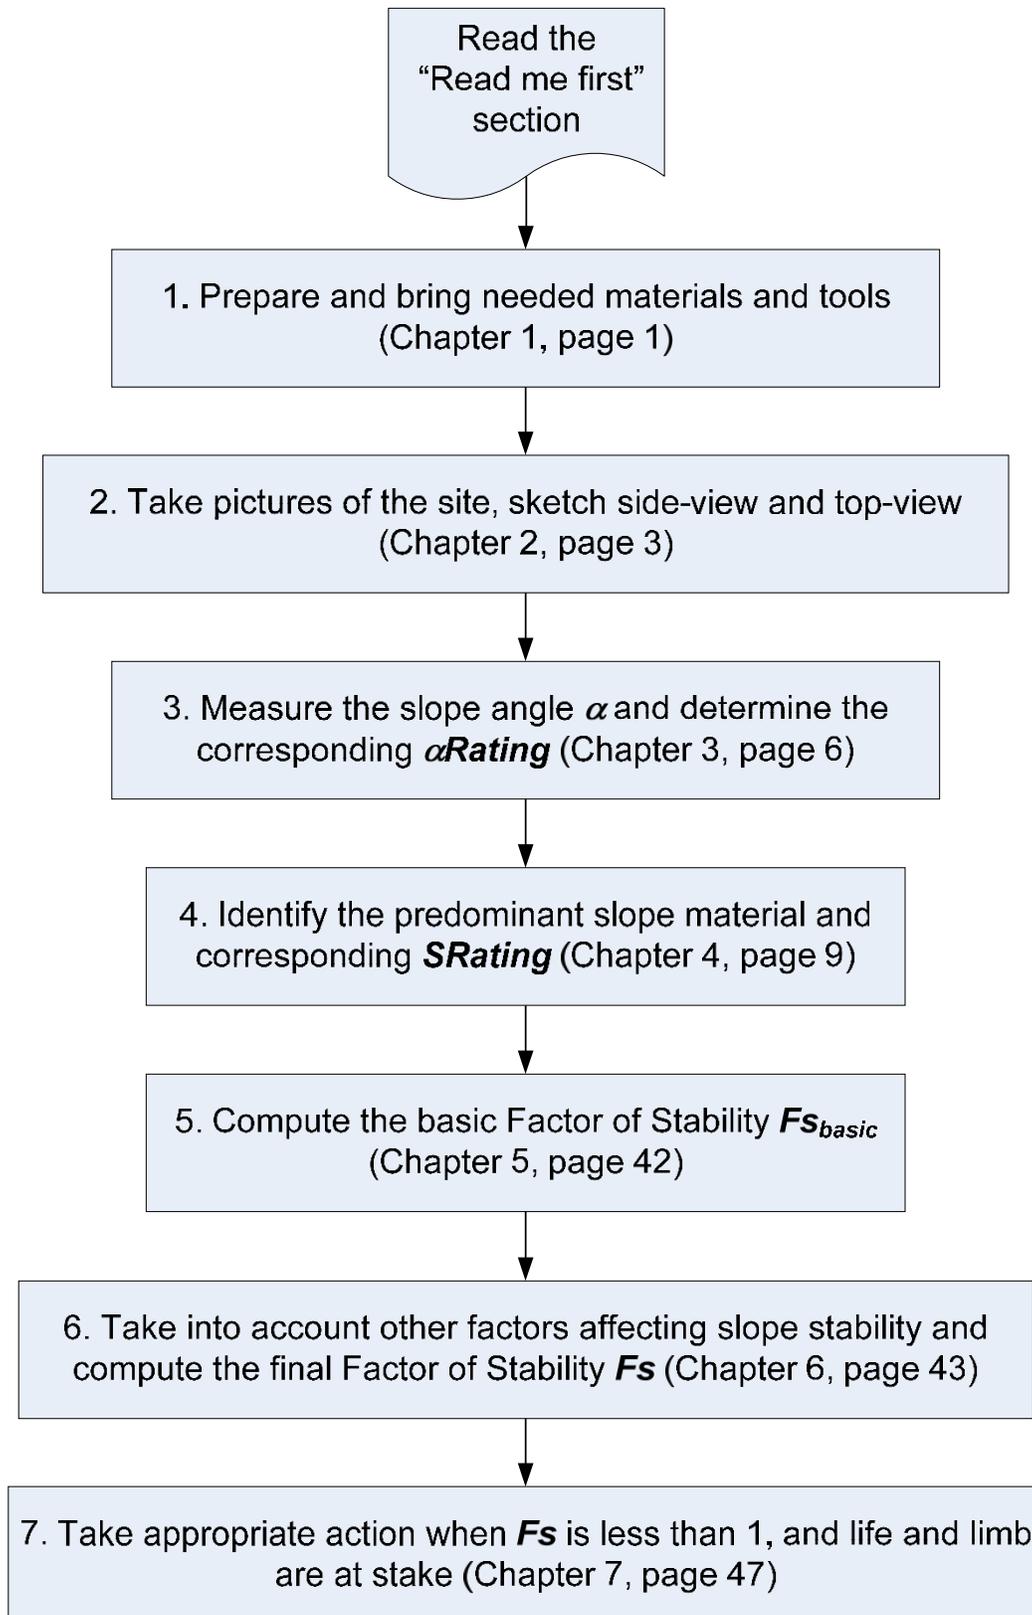
**Figure 3.** Assessment flowchart

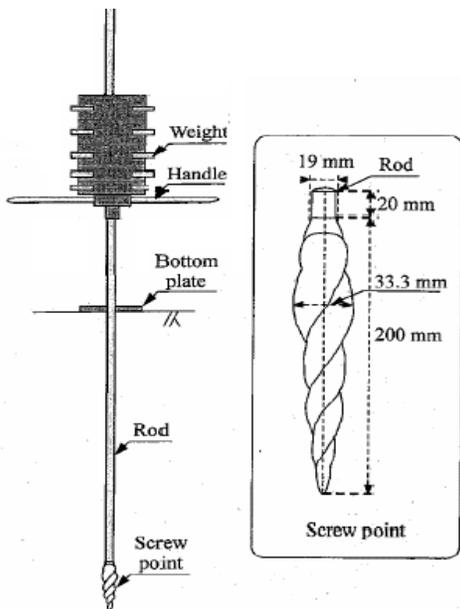
**Figure 1-1.** Swedish weight sounding test (SWST) equipment

<p>1.3 Swedish weight sounding test<sup>1</sup> equipment (optional but recommended for sandy, silty and clayey soils)</p>	<p>(See Figure 1-1 and Photo 1-1)</p>

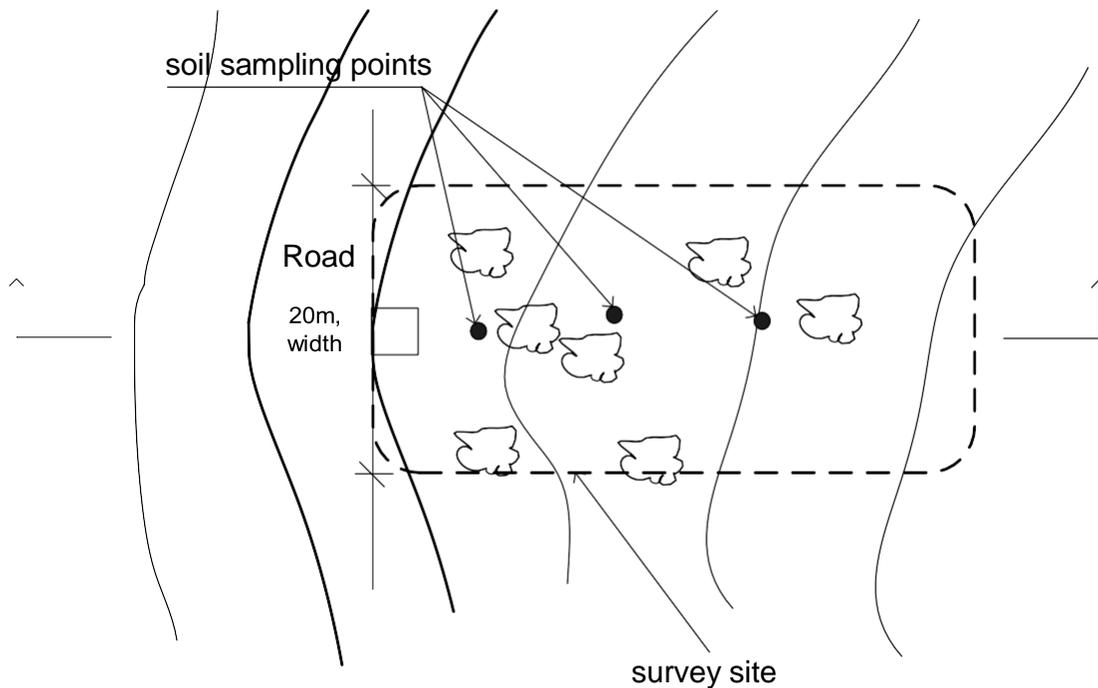
**Figure 2-2.** Site plan or top view

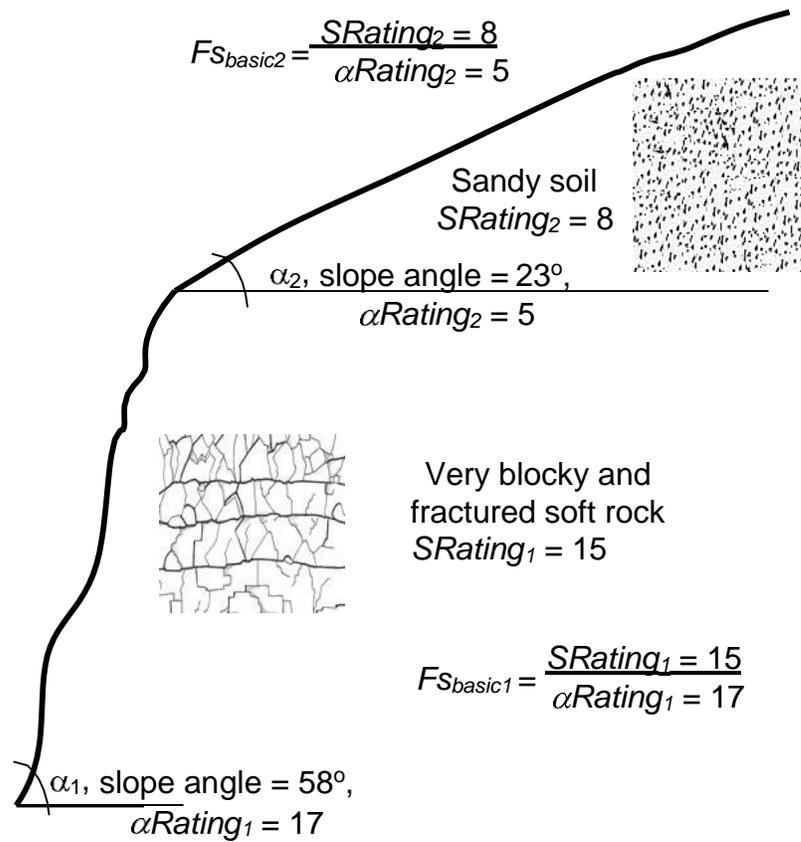
**Figure 2-3.** Slope with varying slope angle and different slope material

Determine the  $F_s$  for each part of the slope.

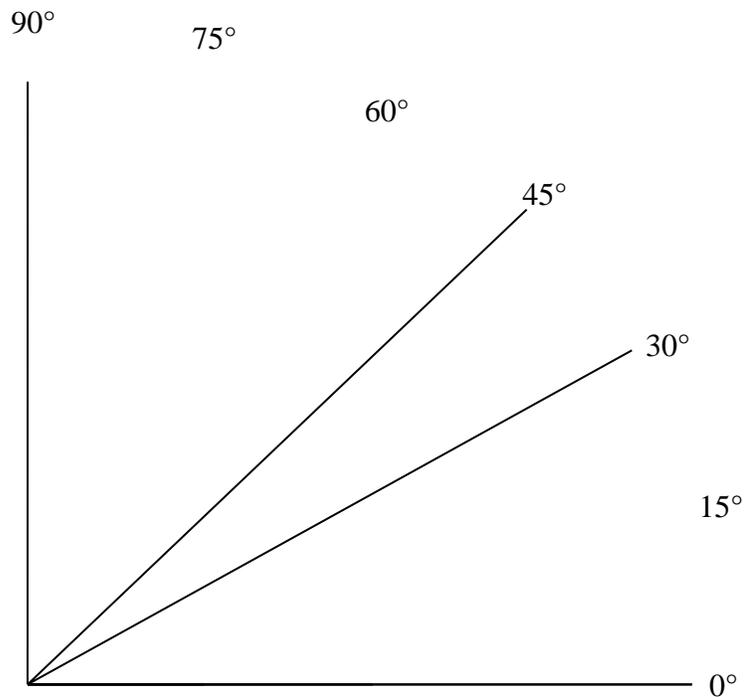
**Figure 3-1.** Slope angles at  $15^\circ$  increments

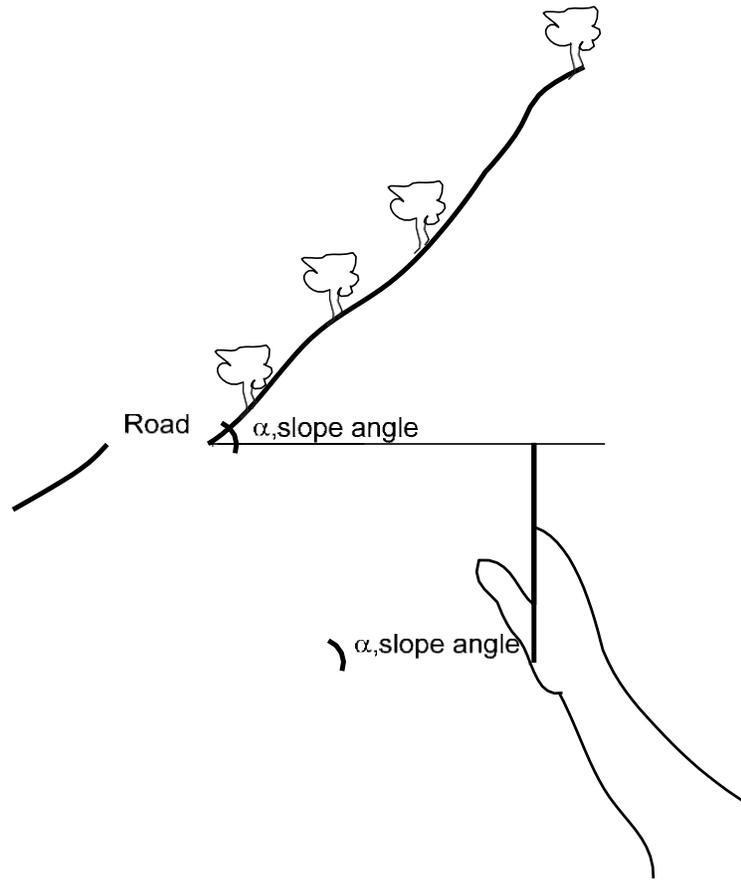
**Figure 3-2.** Comparing a folded-paper angle ( $45^\circ$ ) with the slope angle  $\alpha$

- d. To estimate the slope angle using this technique, find a spot outside the area being investigated where a side-view of the slope can be spotted and the slope angle  $\alpha$  can be visually compared with any of the above paper-fold angles. See **Figure 3-2**.

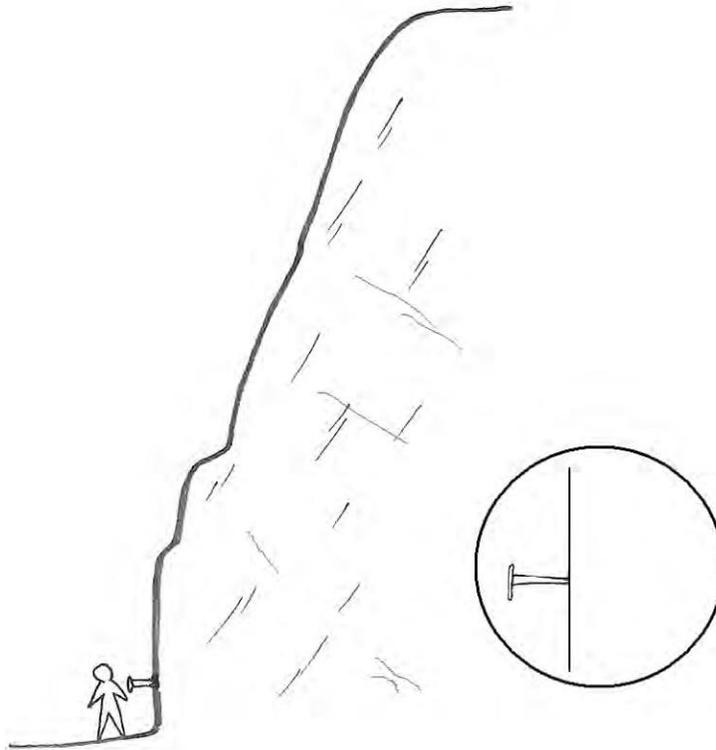
**Figure HR1-1.** Massive and intact hard rock

- a) **hard rock** – cannot be penetrated by 4” common wire nail with a hammer; as hard or harder than concrete ( $\geq 21\text{MPa}$  or 3ksi)
- b) **massive and intact** - few widely spaced cracks or discontinuities, equal or greater than 2m apart, no predominant discontinuity

Given an  $SRating = 100$ , the slope, even if vertical ( $\alpha = 90^\circ$ ), will have an  $F_{Sbasic} = 1$ . See **Table 3-1**.

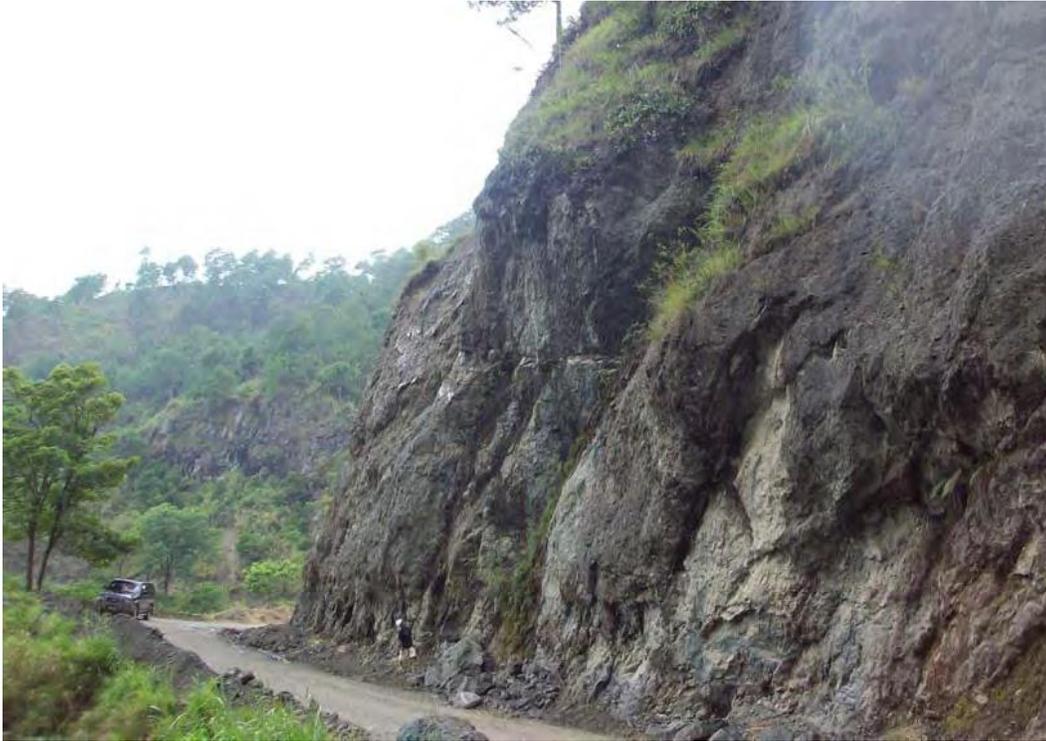
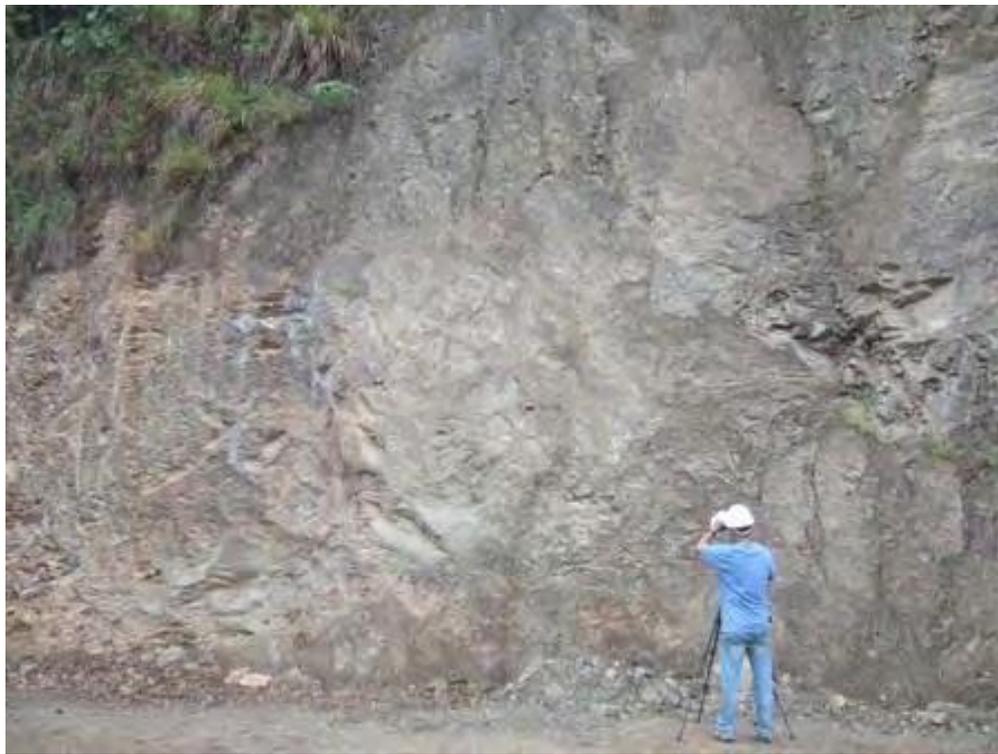
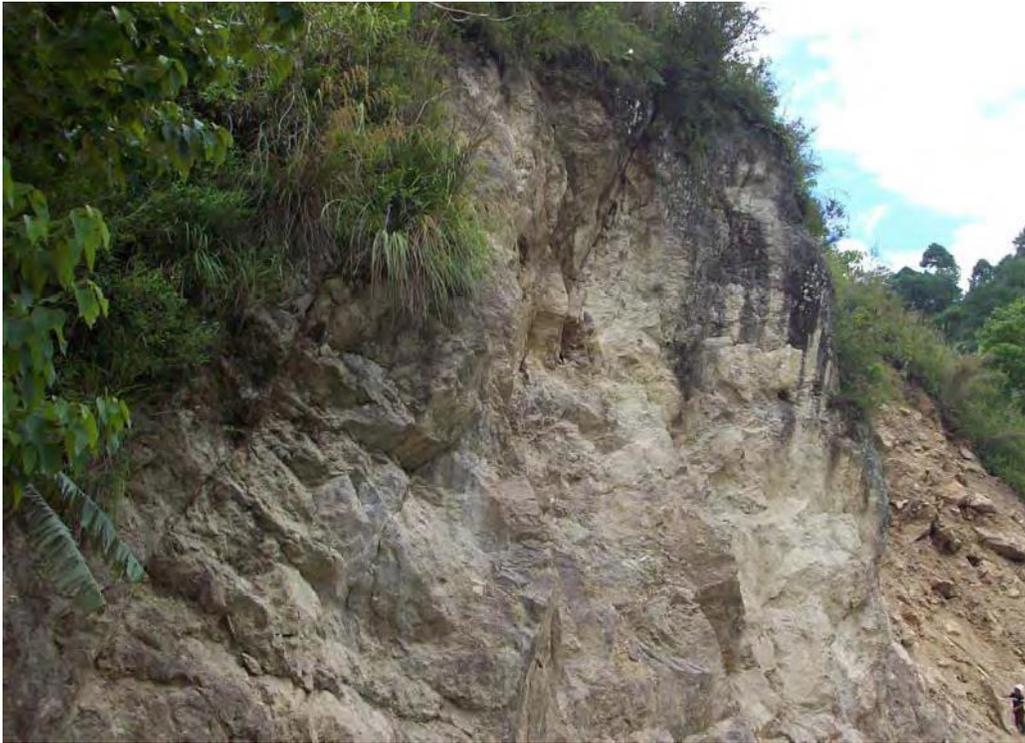
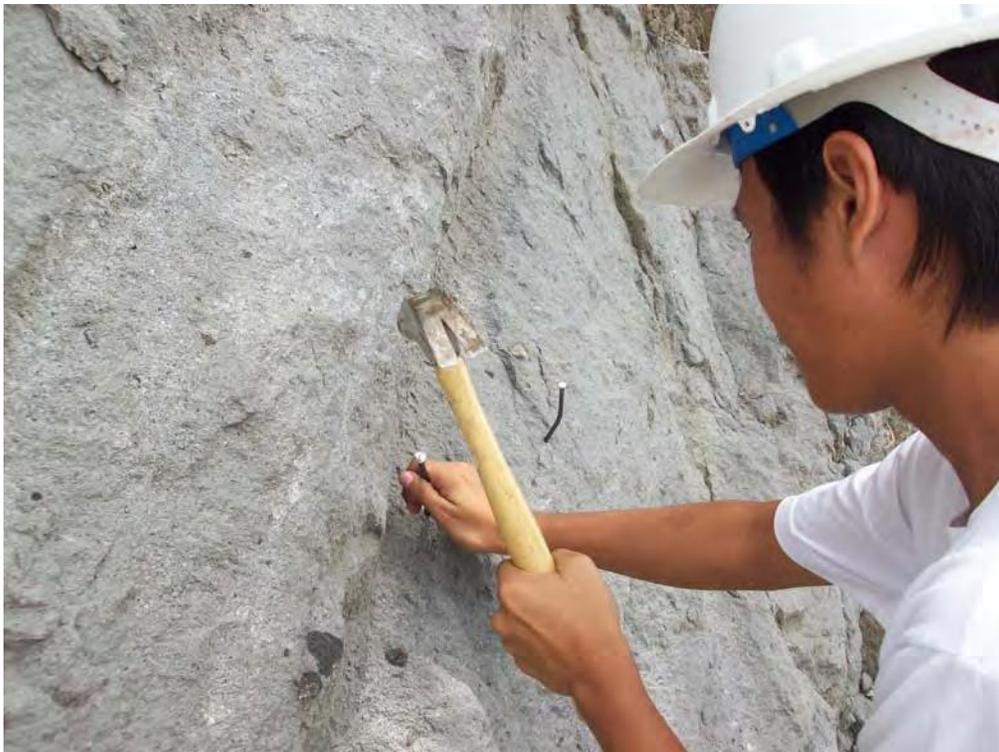
**Photo HR1-1.** massive conglomerate (sedimentary) rock

**Photo HR1-2.** massive andesitic (volcanic) rock

**Photo HR1-3.** massive limestone (sedimentary)

**Photo HR1-4.** massive sandstone (sedimentary), cannot be penetrated by 4" common wire nails

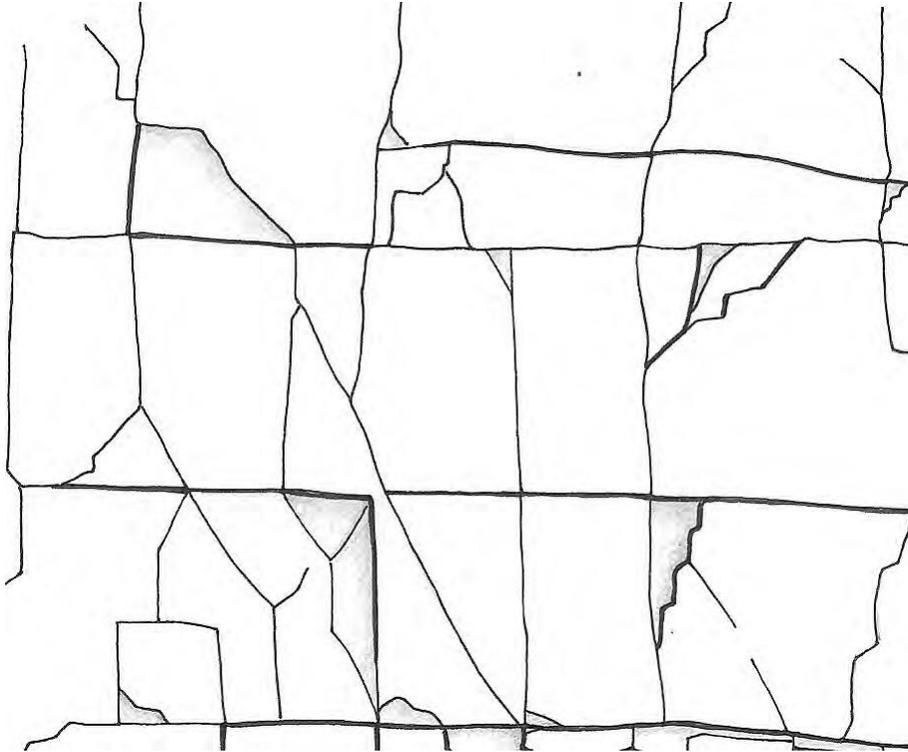
**Figure HR2-1.** Blocky, well-interlocked hard rock

- a) **hard rock** – cannot be penetrated by 4” common wire nail with a hammer; as hard or harder than concrete ( $\geq 21\text{MPa}$  or 3ksi)
- b) **size of blocks** mostly between 60cm (2ft) to 2m (around 6ft)

Given an  $SR_{\text{Rating}} = 45$ , the maximum slope angle  $\alpha$  for this material to be stable would be  $75^\circ$ , according to **Table 3-1**.  
 $F_{S_{\text{basic}}} = 1.4$ .

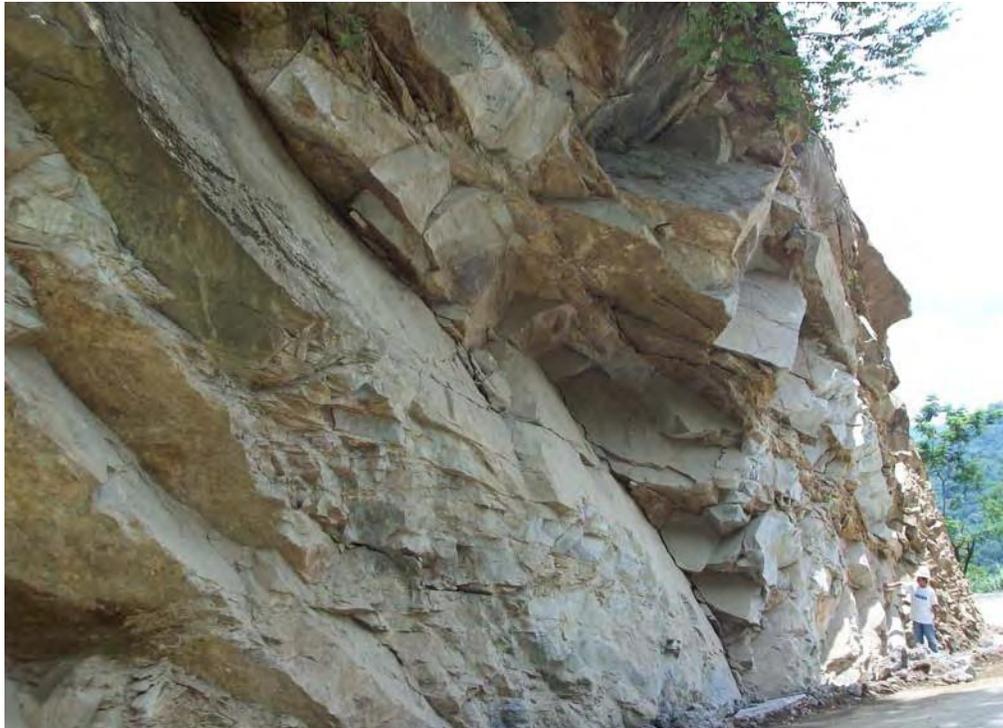
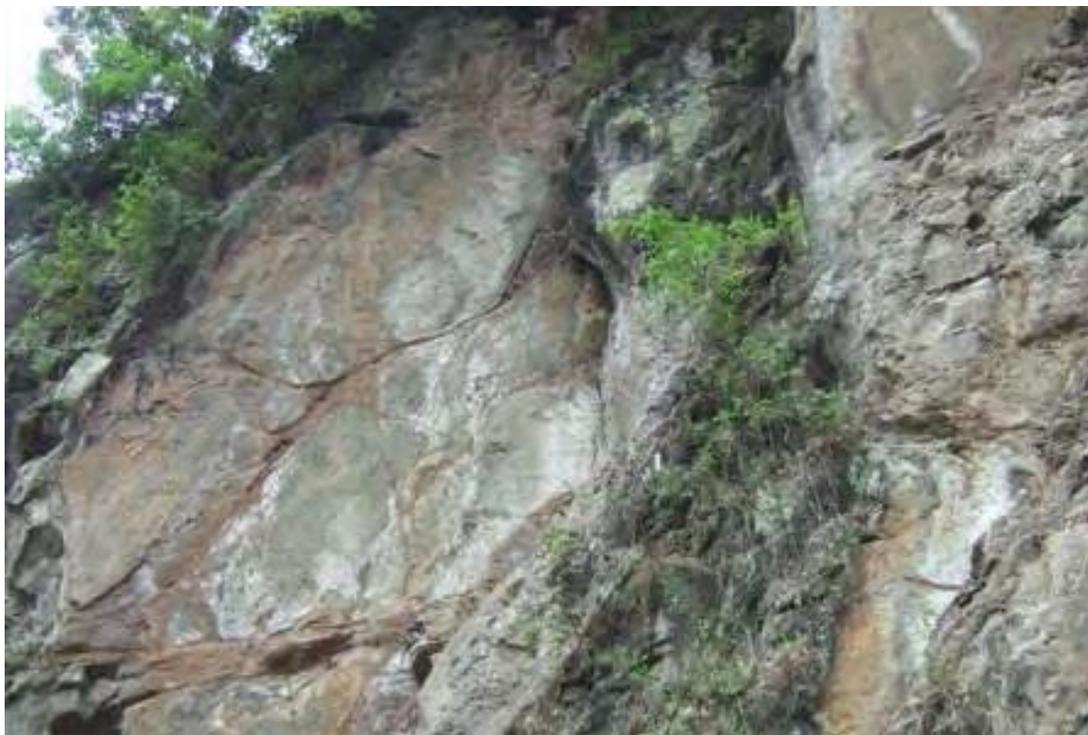
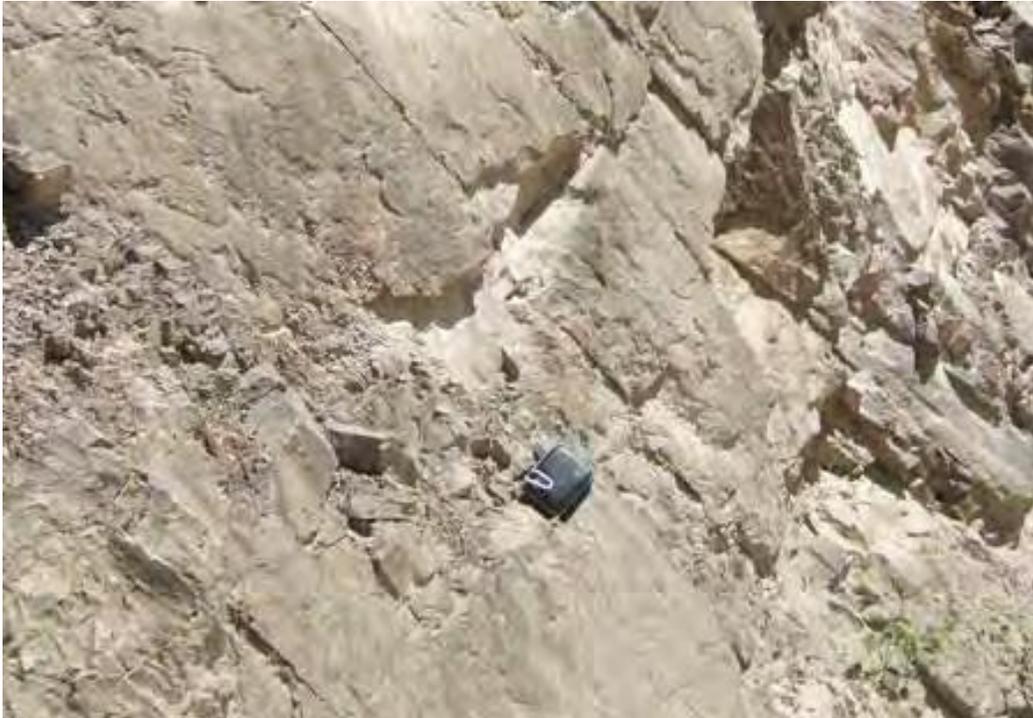
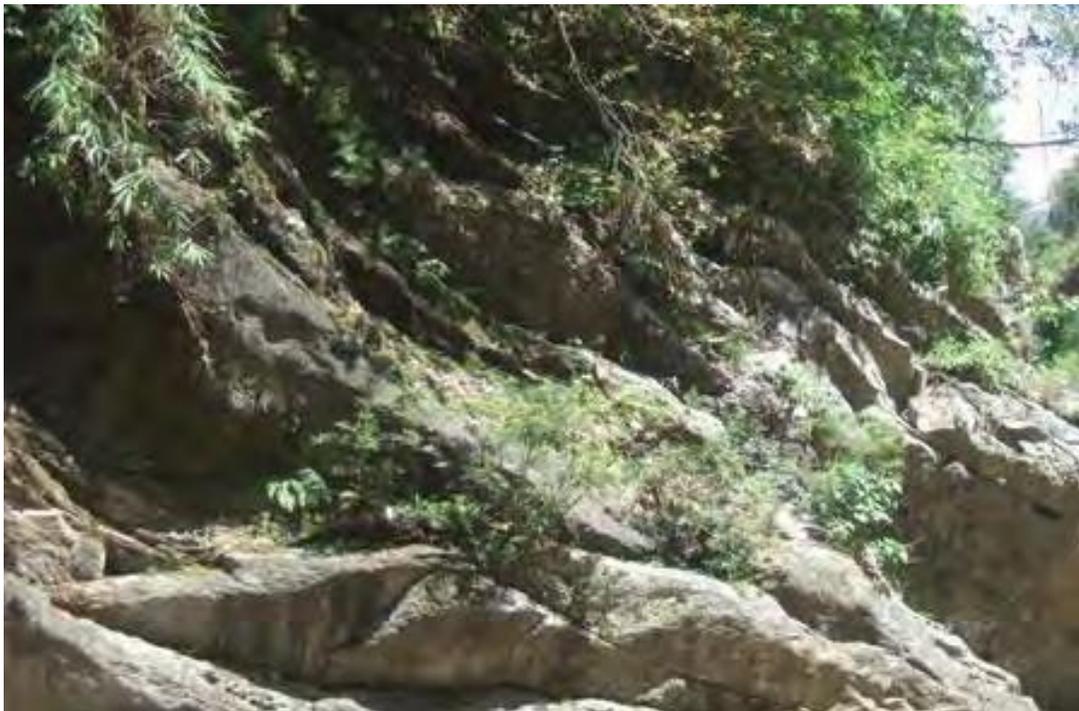
**Photo HR2-1.** blocky granodioritic (volcanic) rock

**Photo HR2-2.** blocky sandstone (sedimentary) with conglomerate

**Photo HR2-3.** Blocky sandstone (sedimentary)

**Photo HR2-4.** blocky sandstone and conglomerate (sedimentary)

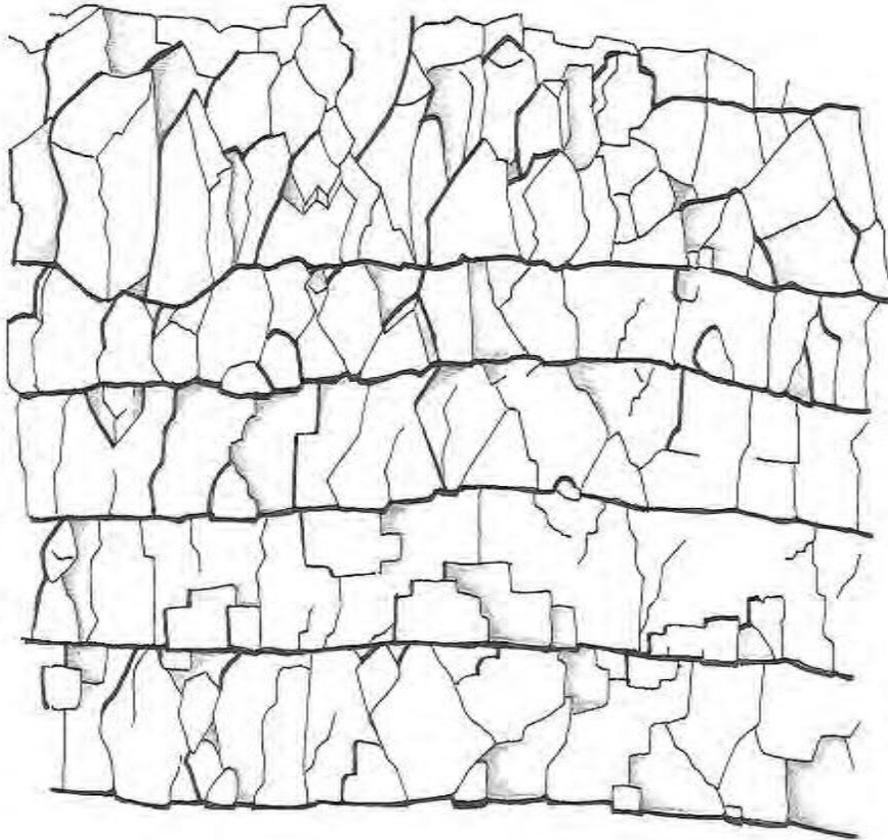
**Figure HR3-1.** Very blocky, fractured and disturbed hard rock  
a) **hard rock** – cannot be penetrated by 4” common wire nail with a hammer; as hard or harder than concrete ( $\geq 21\text{MPa}$  or 3ksi)  
b) **size of blocks** mostly between 10cm (4inches) to 60cm (around 2ft)

Given an  $SR_{\text{Rating}} = 25$ , the maximum slope angle  $\alpha$  for this material to be stable would be  $60^\circ$ , according to **Table 3-1**.  
 $F_{S_{\text{basic}}} = 1.5$ .

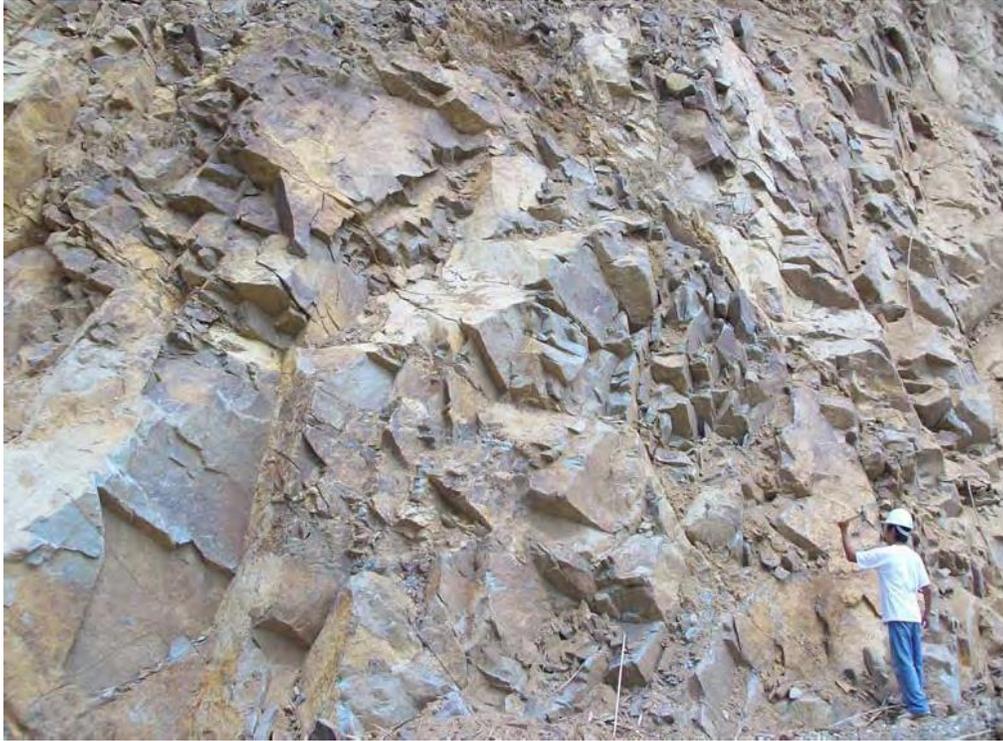
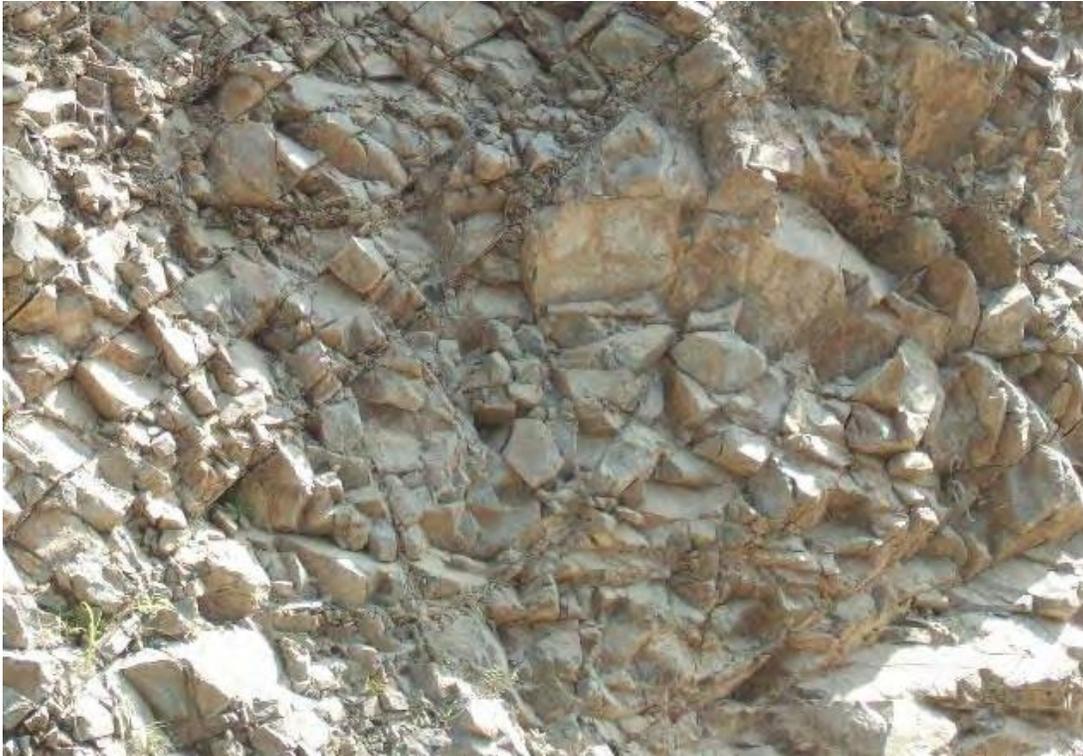
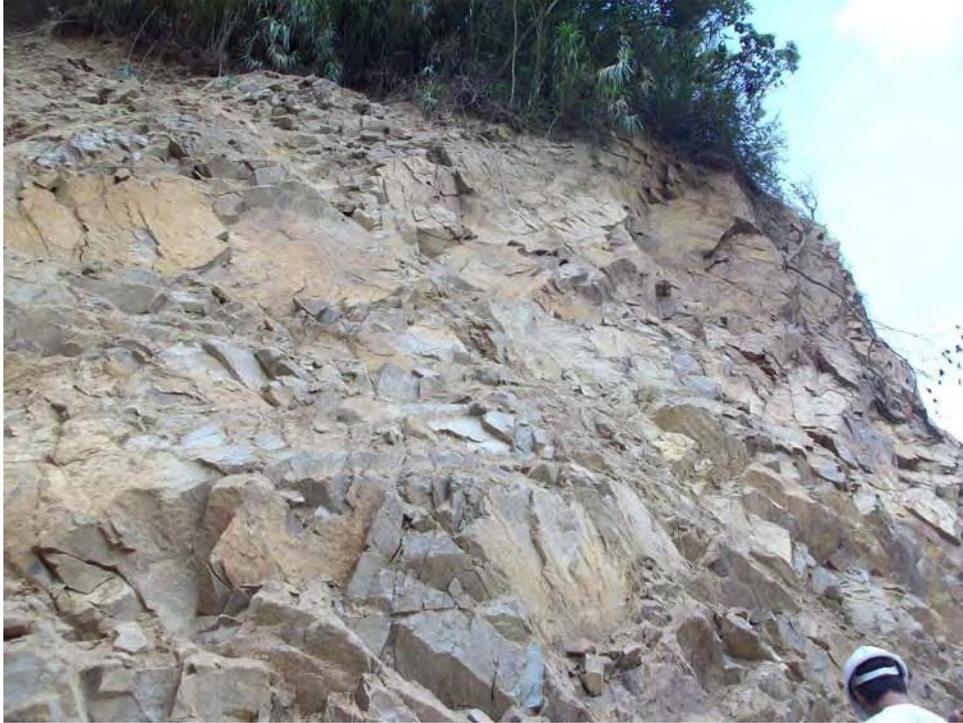
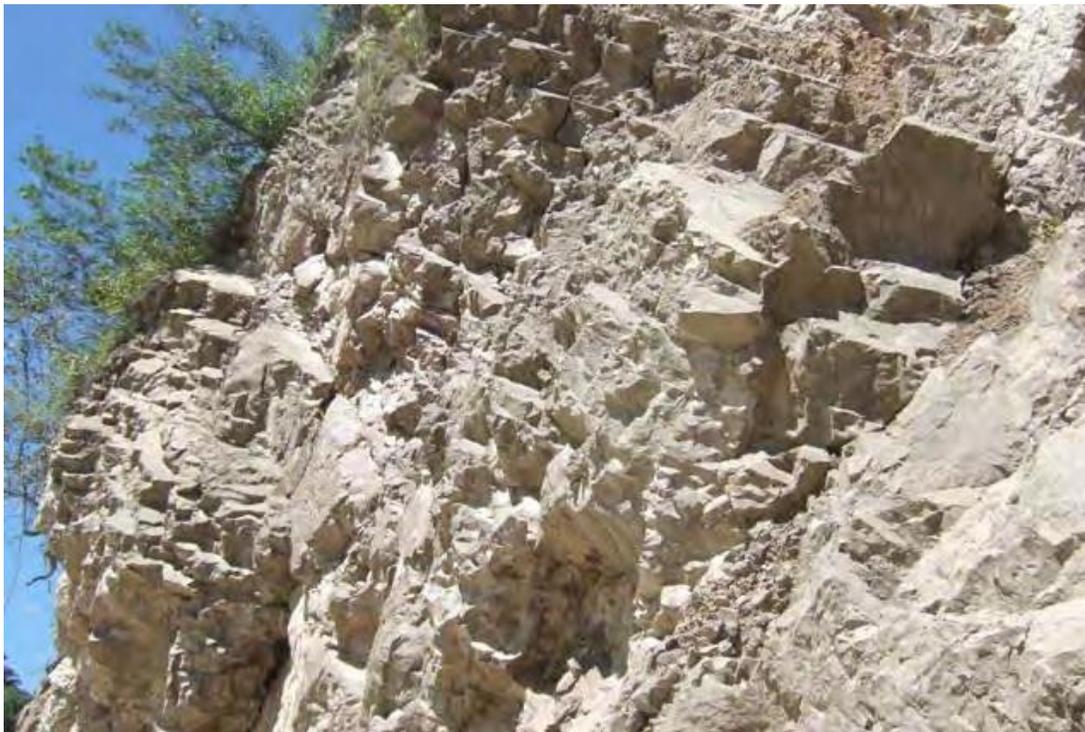
**Photo HR3-1.** Very blocky and highly fractured granodioritic (volcanic) rock

**Photo HR3-2.** Highly fractured sedimentary rocks

**Photo HR3-3.** highly fractured hard rock

**Photo HR3-4.** highly fractured sandstone and conglomerate (sedimentary)

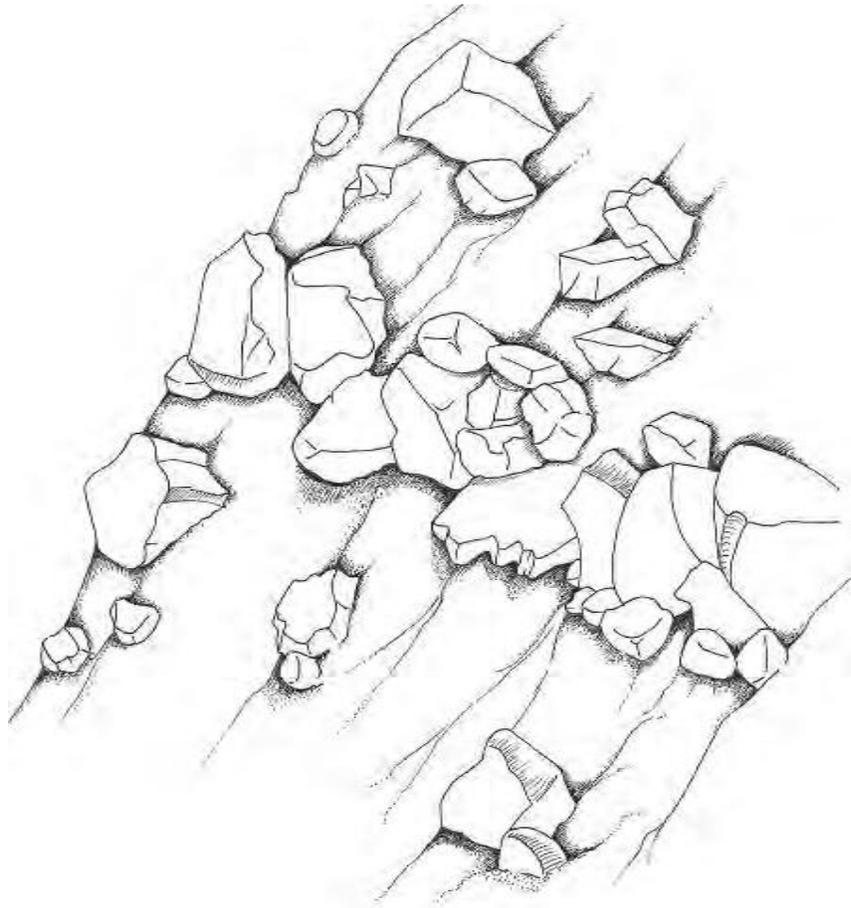
**Figure HR4-1.** Disintegrated, unstable and protruding rocks  
a) may include **soft rock fragments**  
b) **size of blocks** varies

Given an  $SR_{Rating} = 13$ , the maximum slope angle  $\alpha$  for this material to be stable would be  $45^\circ$ , according to **Table 3-1**.  
 $F_{S_{basic}} = 1.3$ . Note that the effects of other factors are not considered in  $F_{S_{basic}}$ .

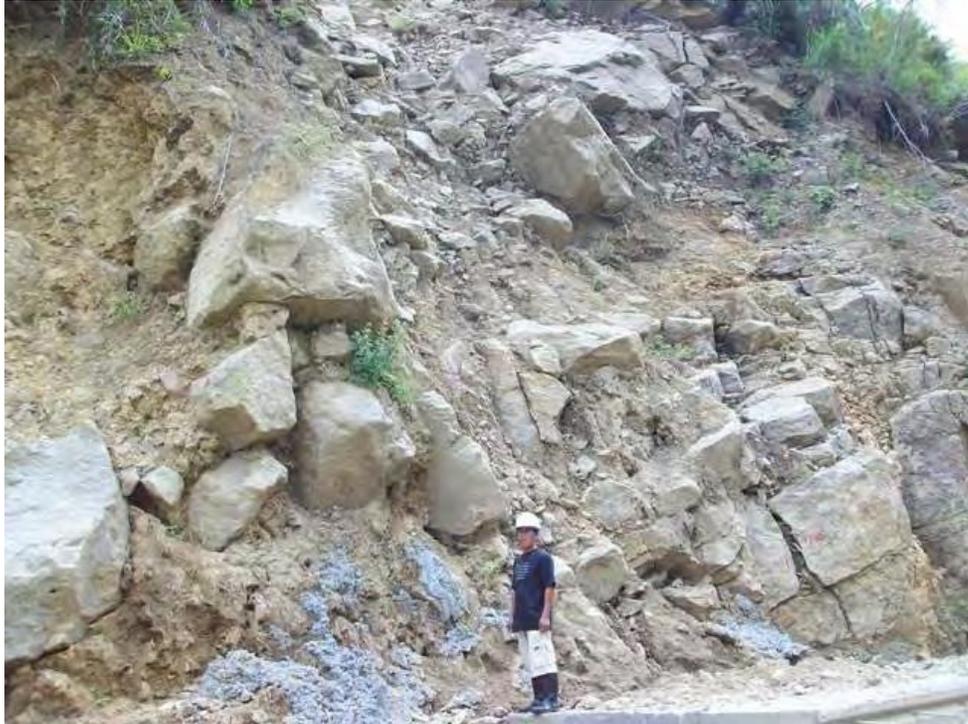
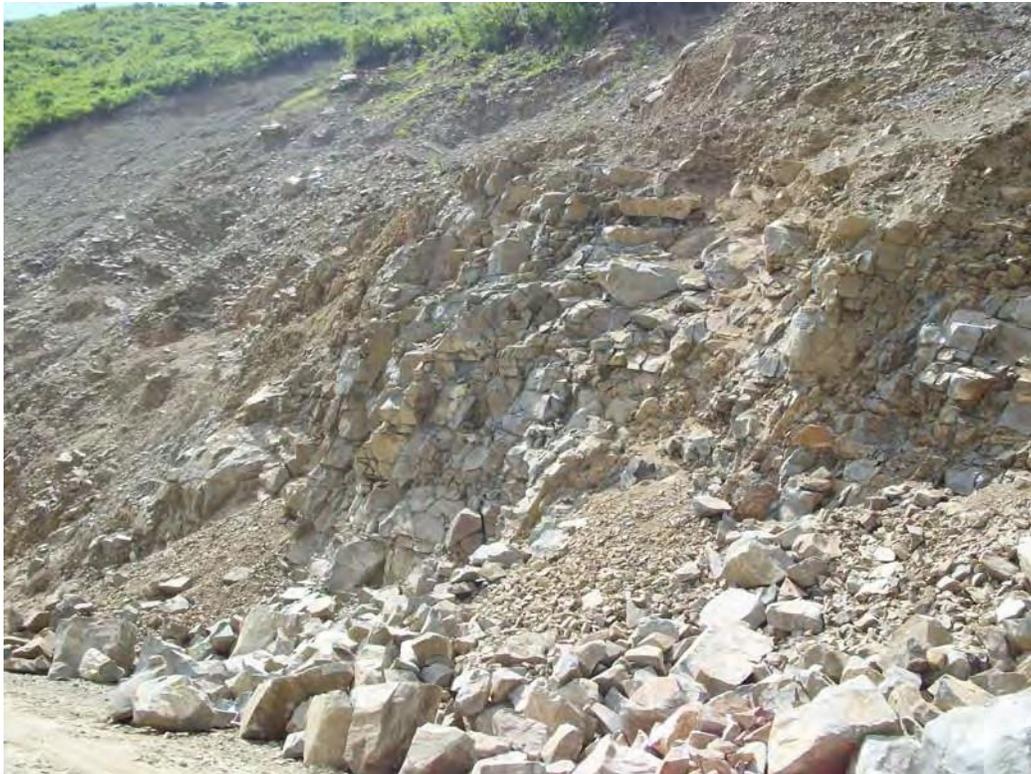
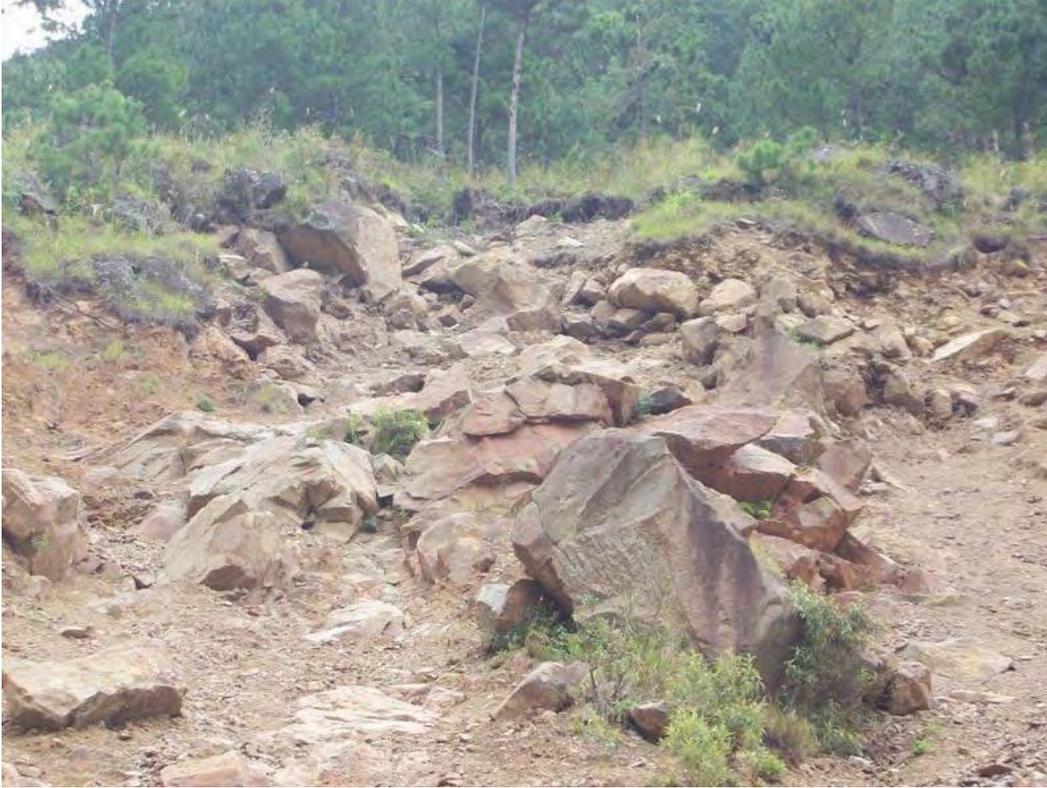
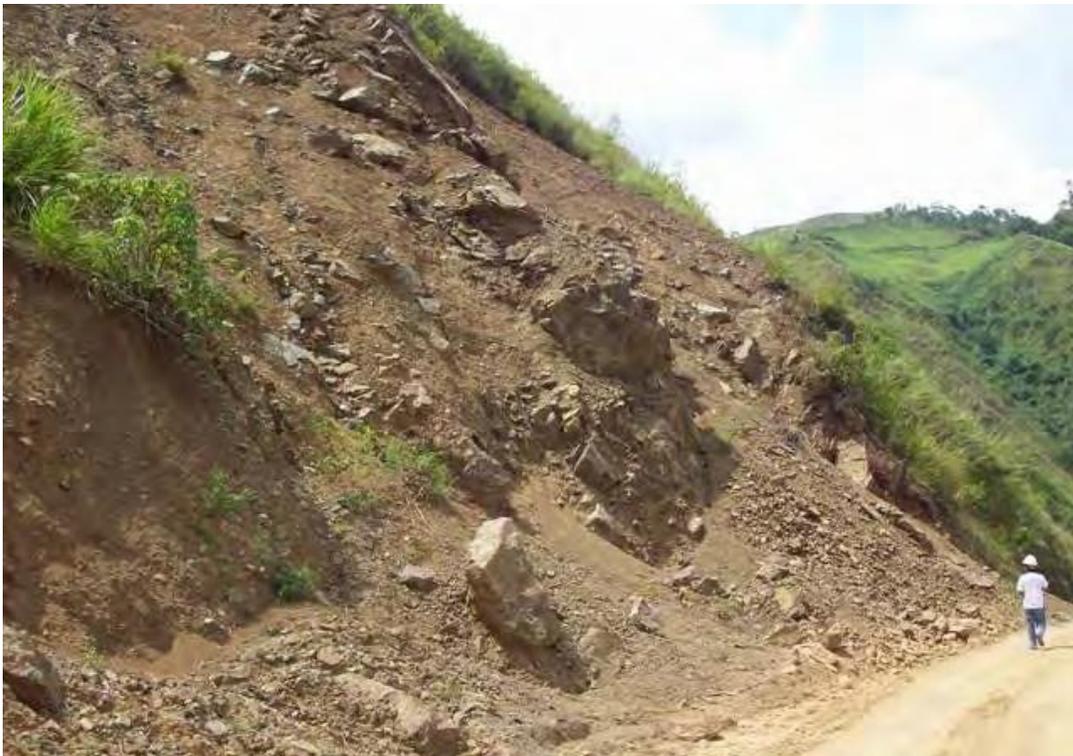
**Photo HR4-1.** Disintegrated and protruding boulders and fragments

**Photo HR4-2.** Disintegrated volcanic rocks

**Photo HR4-3.** Protruding boulders

**Photo HR4-4.** Another slope with protruding boulders and rock fragments

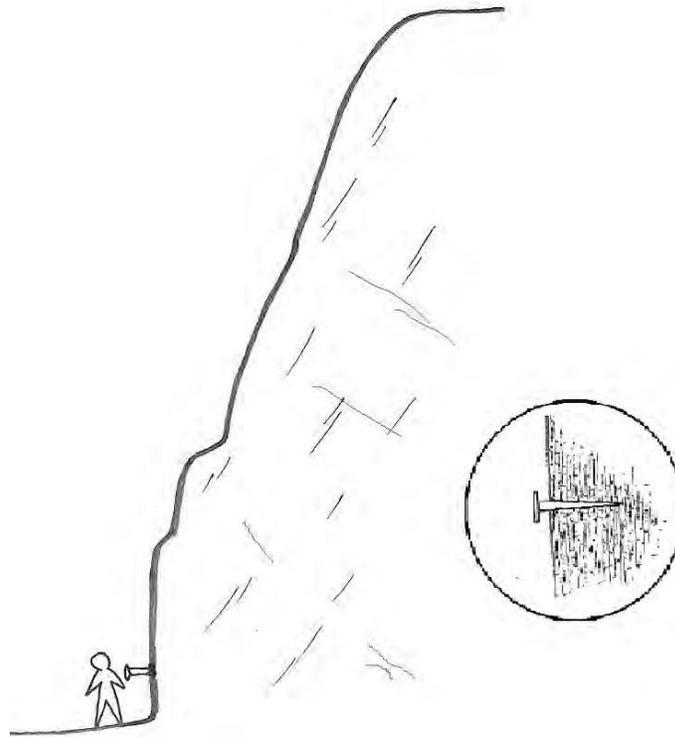
**Figure SR1-1.** Massive and intact soft rock

- a) **soft rock** – can be penetrated by a 4” common wire nail with hammer; weaker than concrete (< 21MPa or 3ksi) but a fist-sized sample will not crumble or deform with hand pressure
- b) **massive and intact** - few widely spaced cracks or discontinuities, equal or greater than 2m apart, no predominant discontinuity

Given an  $SR_{rating} = 30$ , the maximum slope angle  $\alpha$  for this material to be stable would be  $60^\circ$ , according to **Table 3-1**.  
 $F_{S_{basic}} = 1.8$ .
