# **RAIN-INDUCED LANDSLIDE SUSCEPTIBILITY: A GUIDEBOOK FOR COMMUNITIES & NON-EXPERTS**

**A Guidebook for Communities and Non-Experts**

This guidebook offers a simplified susceptibility assessment of rain-induced, shallow-depth landslides. The assessment procedure takes off from the idea that the strength of the material or structure **S** should always be greater than the applied load or force **L** (**S**>**L**). This concept could be expressed as a factor commonly referred in engineering as Factor of Safety  $F_s = S/L$ , which should always be greater than 1. **Figure 1** below illustrates the concept:

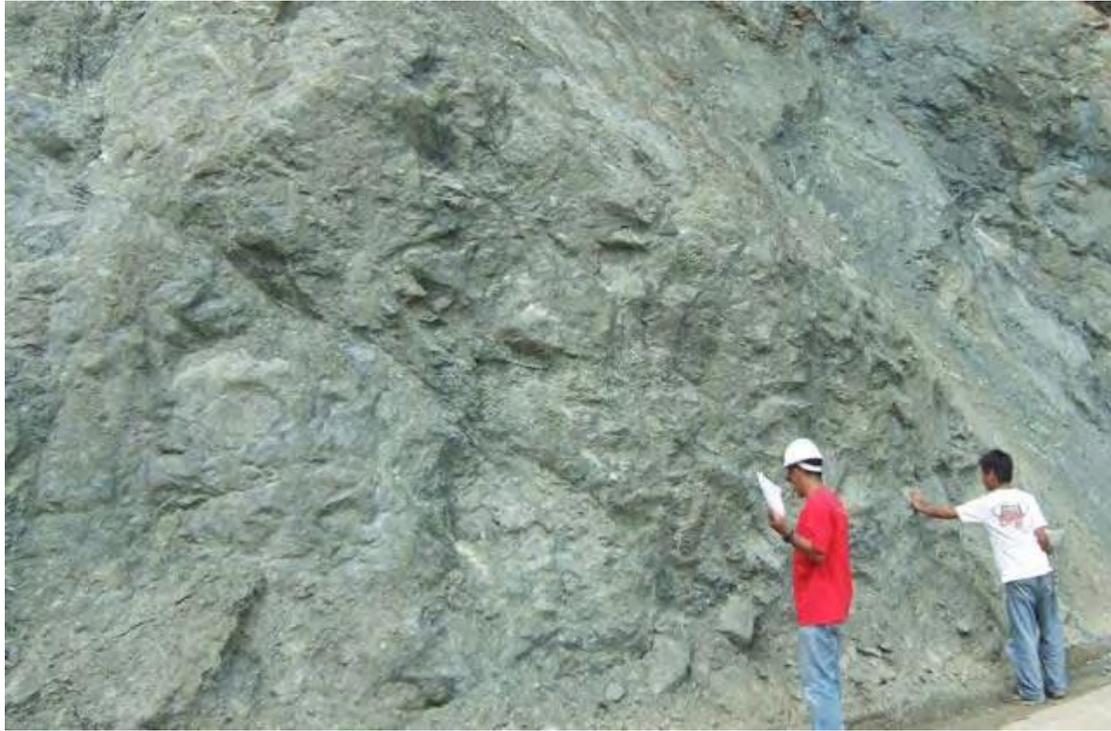
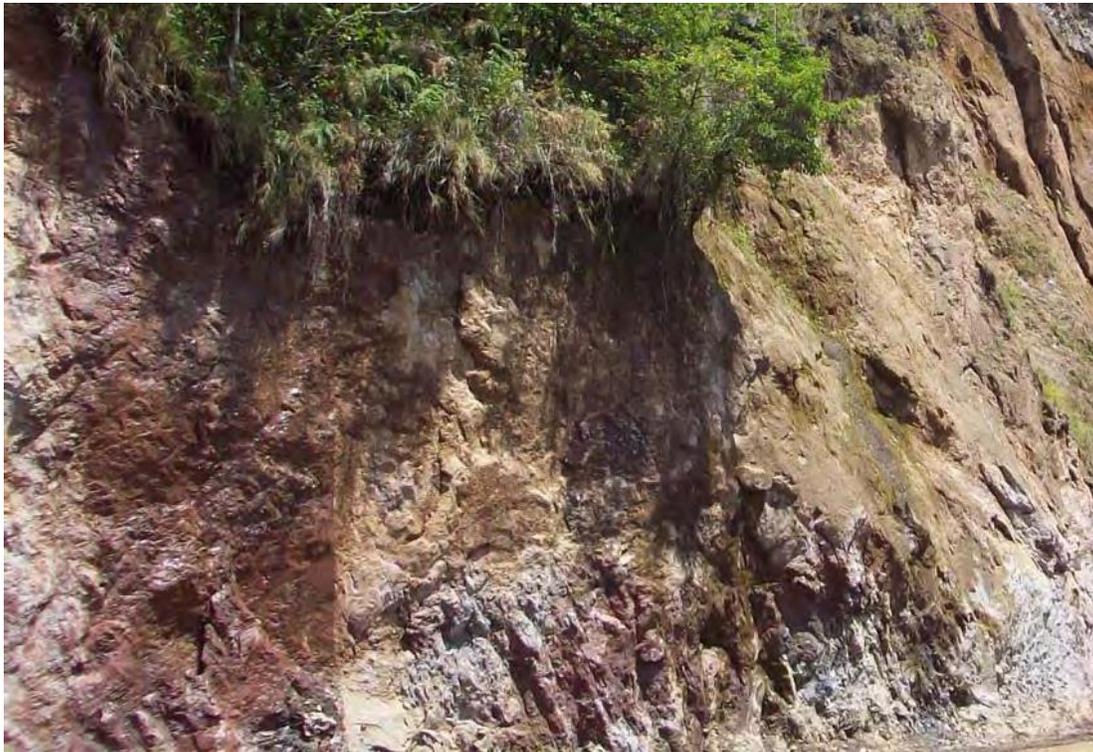
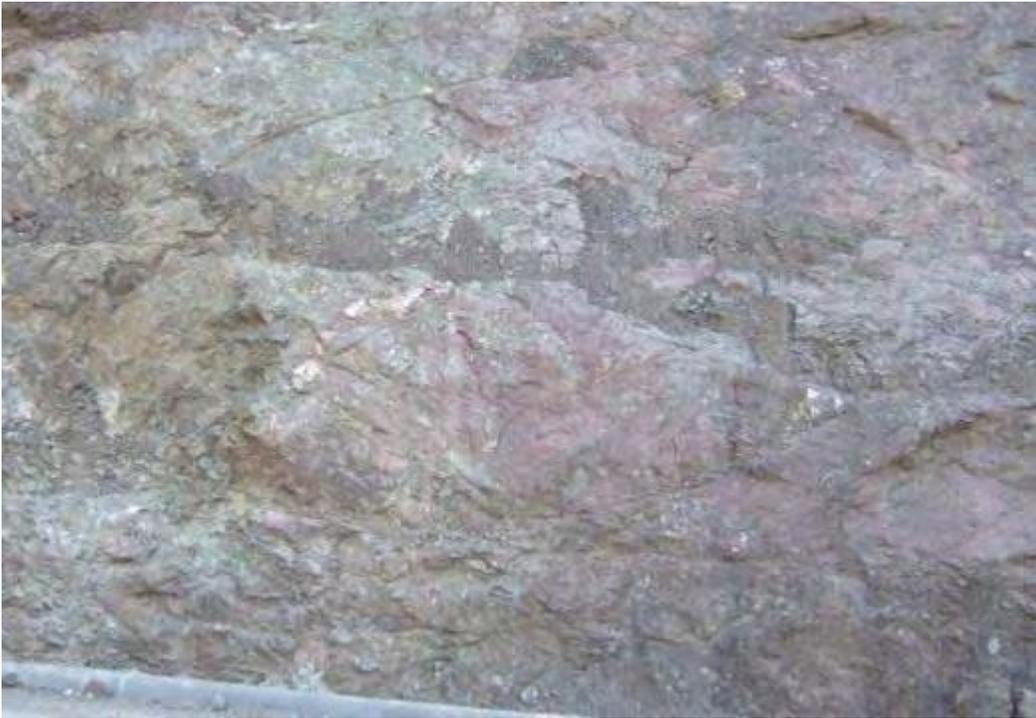
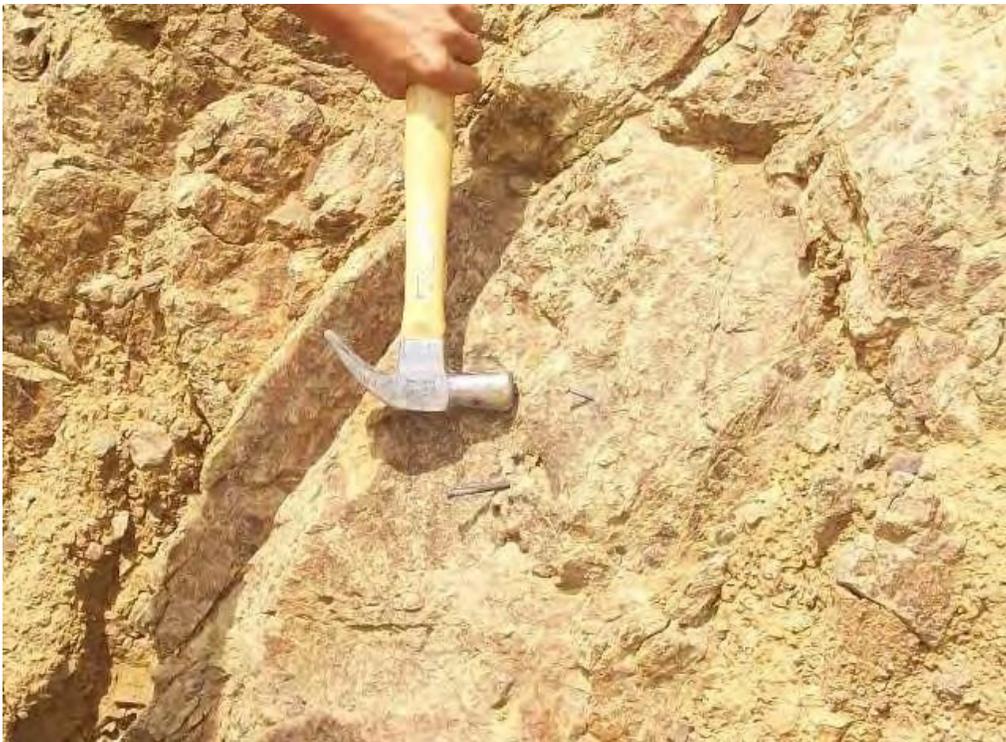
**Photo SR1-1.** Massive soft conglomerate (sedimentary)

**Photo SR1-2.** Massive soft rock with a spring (left side)

**Photo SR1-3.** Massive soft rock,

**Photo SR1-4.** Massive soft rock, can be penetrated by common wire nails (softer than concrete)

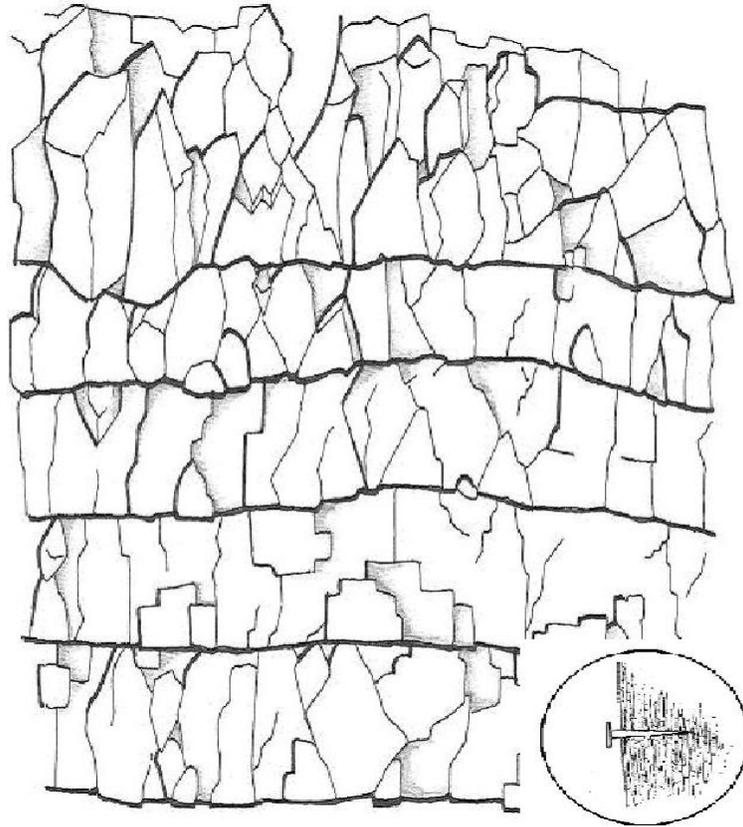
**Figure SR2-1.** Very blocky and fractured soft rock

Given an  $SR_{\text{Rating}} = 15$ , the maximum slope angle  $\alpha$  for this material to be stable would be  $45^\circ$ , according to **Table 3-1**.  
 $F_{S_{\text{basic}}} = 1.5$ .

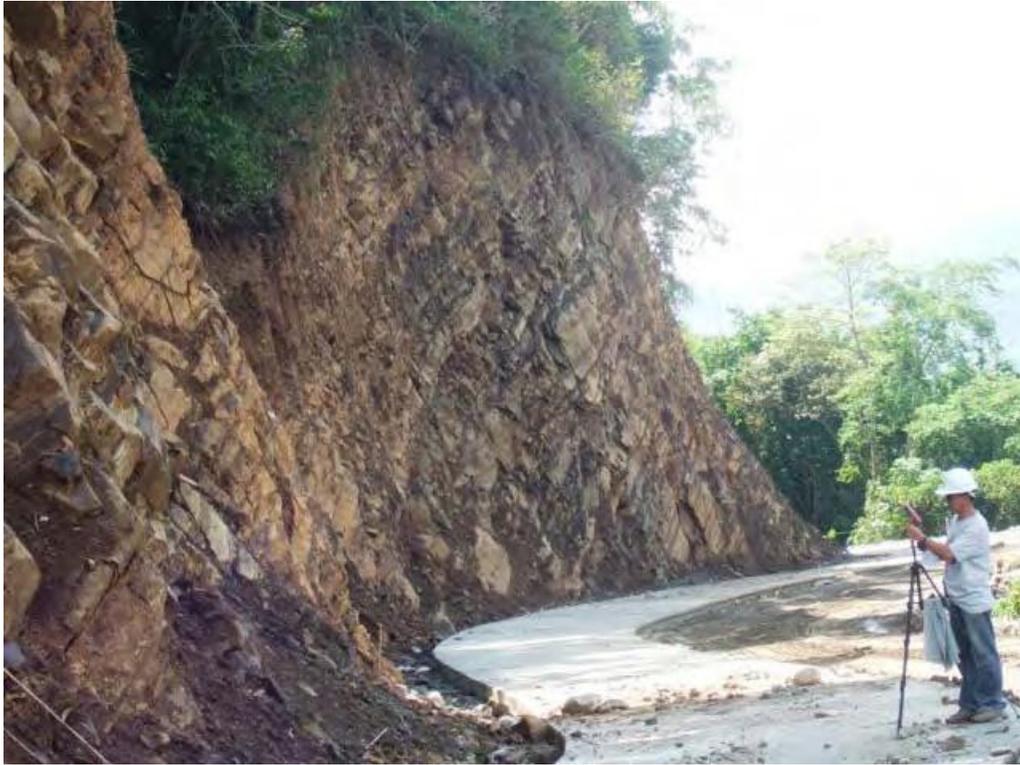
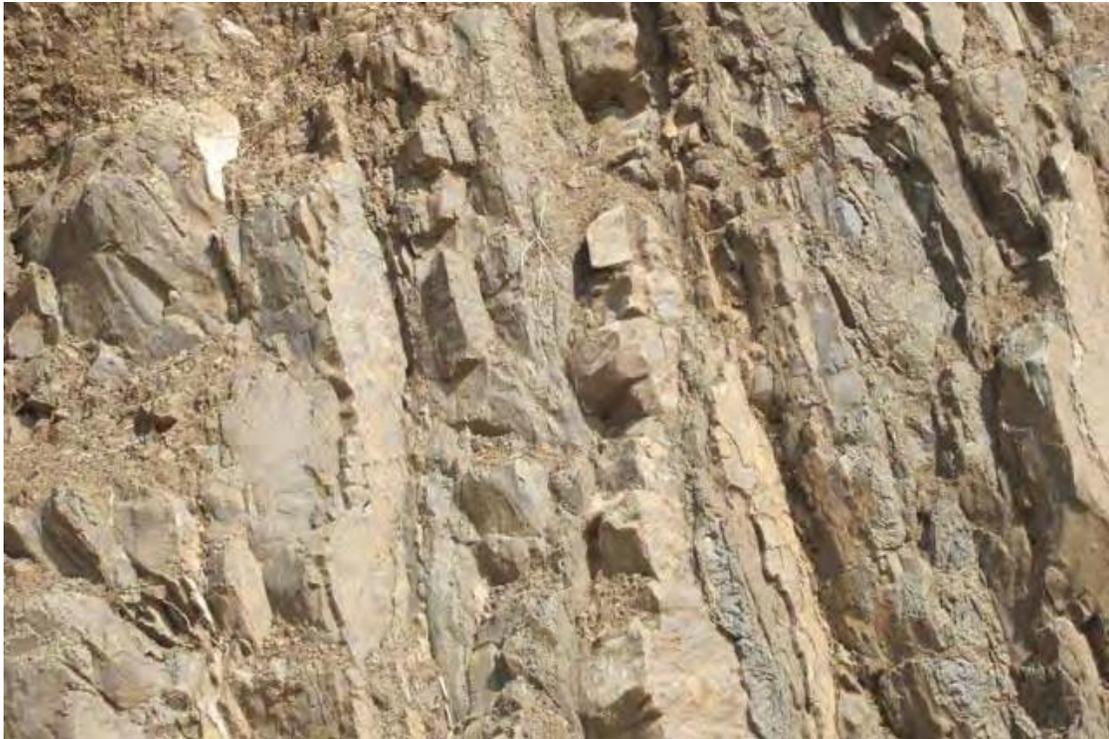
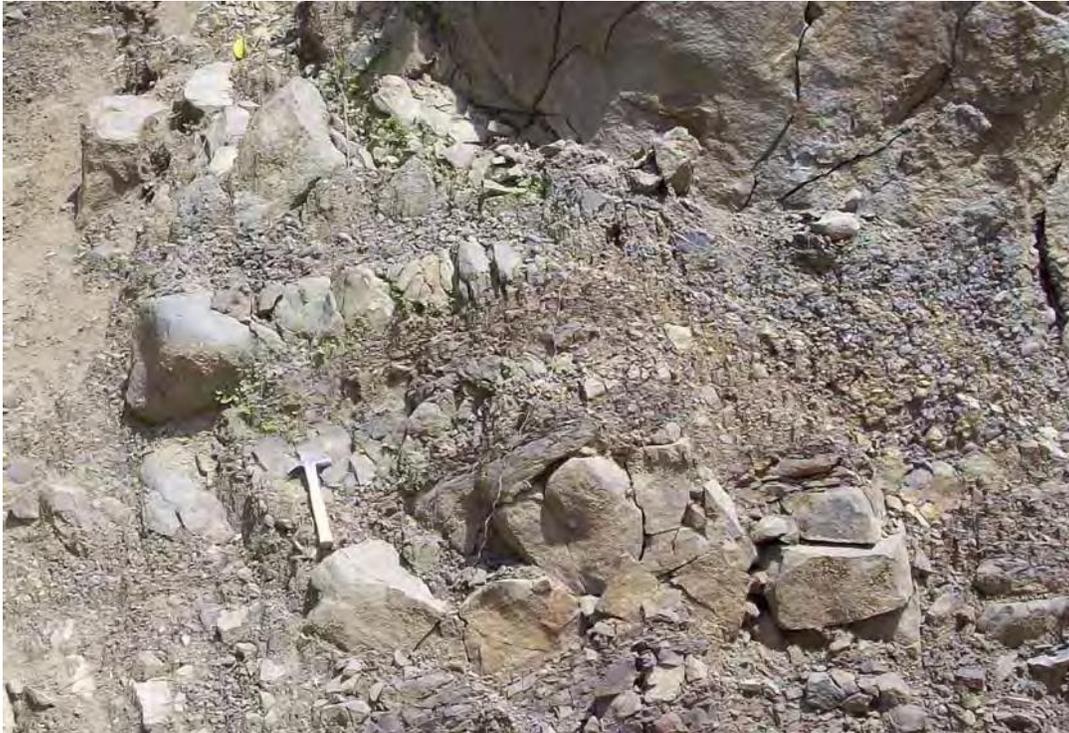
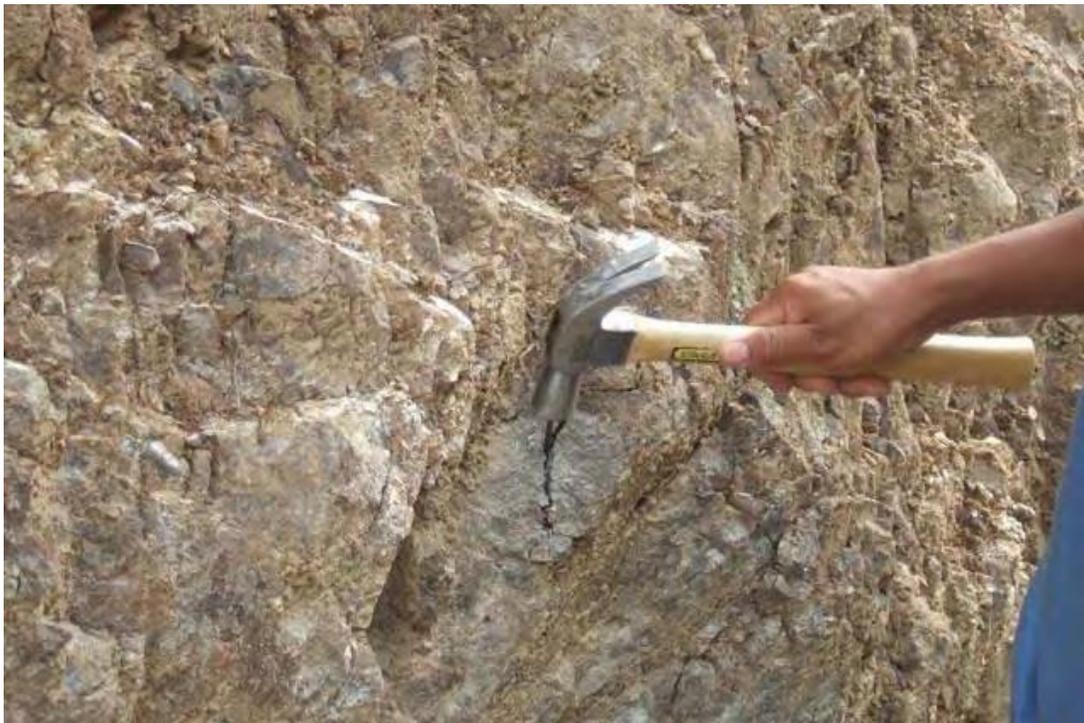
**Photo SR2-1.** Fractured soft sedimentary rock

**Photo SR2-2.** Fractured soft sandstone interbedded with siltstones/mudstones

**Photo SR2-3.** Fractured soft sandstones with conglomerate

**Photo SR2-4.** Fractured soft rock, can be penetrated by common wire nails (softer than concrete)

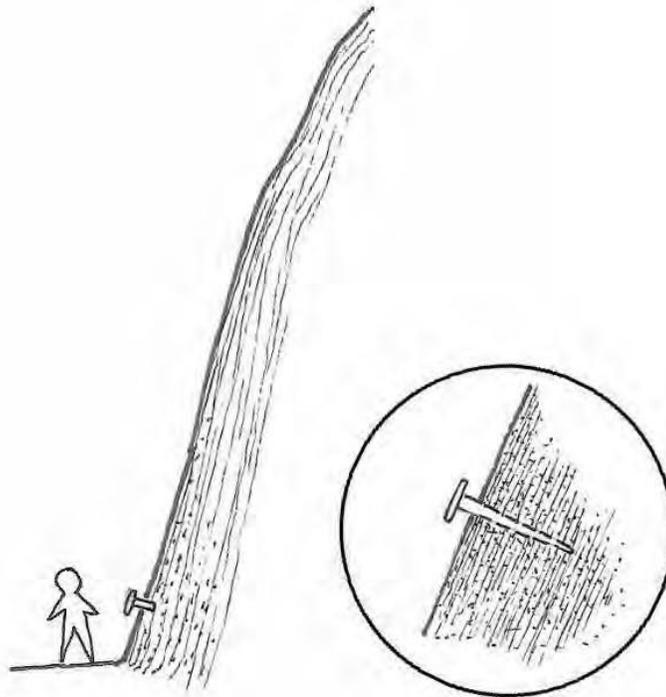
**Figure HS1-1:** Stiff, cemented and dense gravelly, sandy, silty and clayey soils

Unless a definitive test (e.g. SWST) was conducted to establish that the slope material belongs to this classification, use of this classification is discouraged.

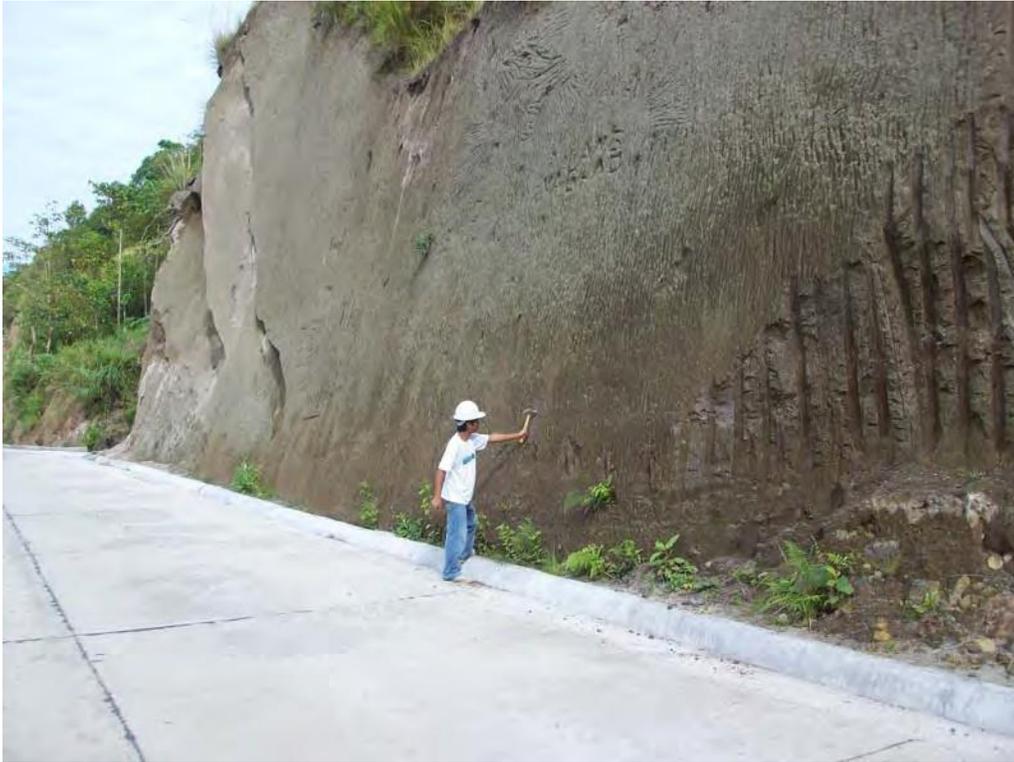
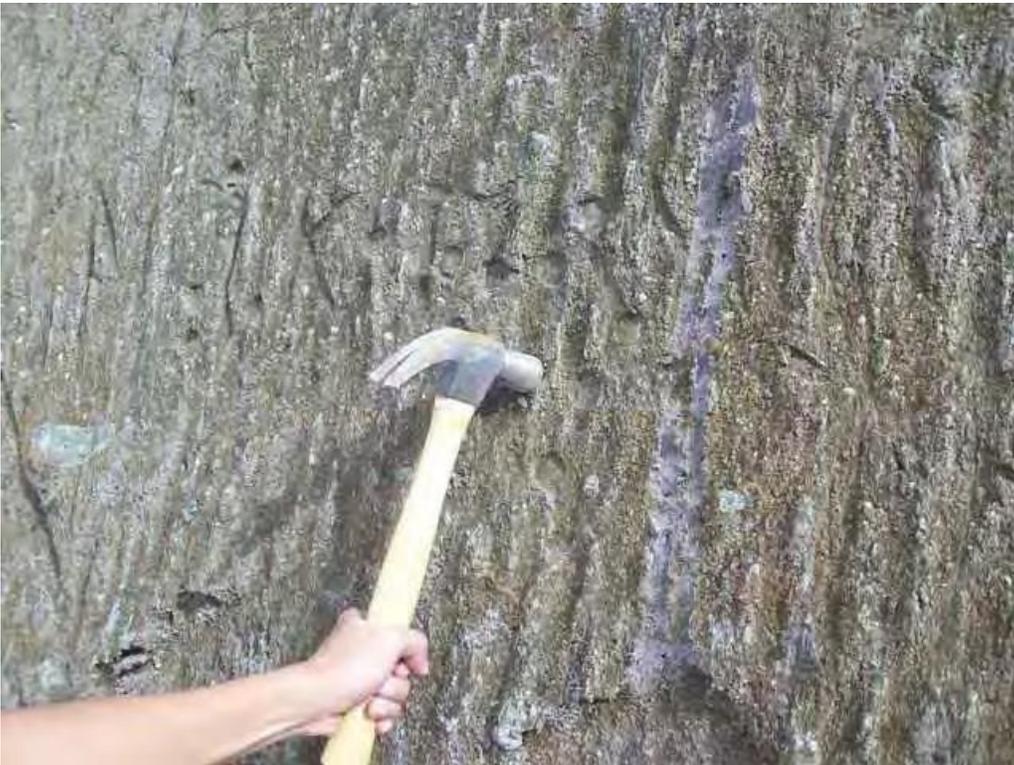
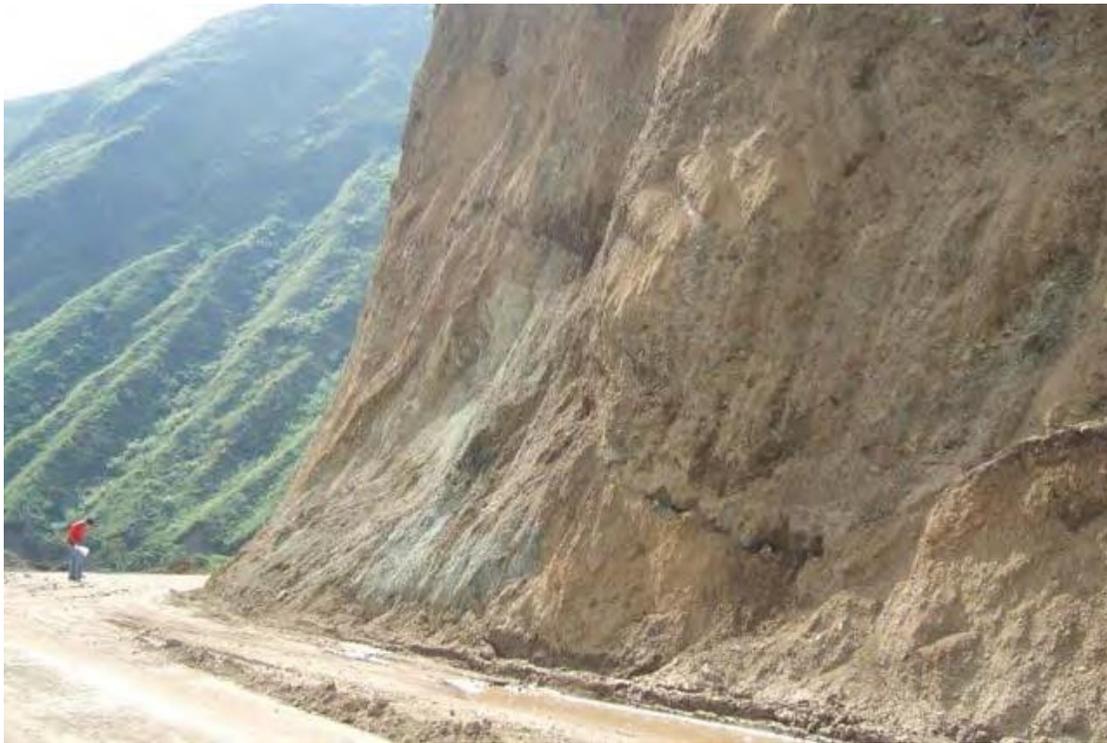
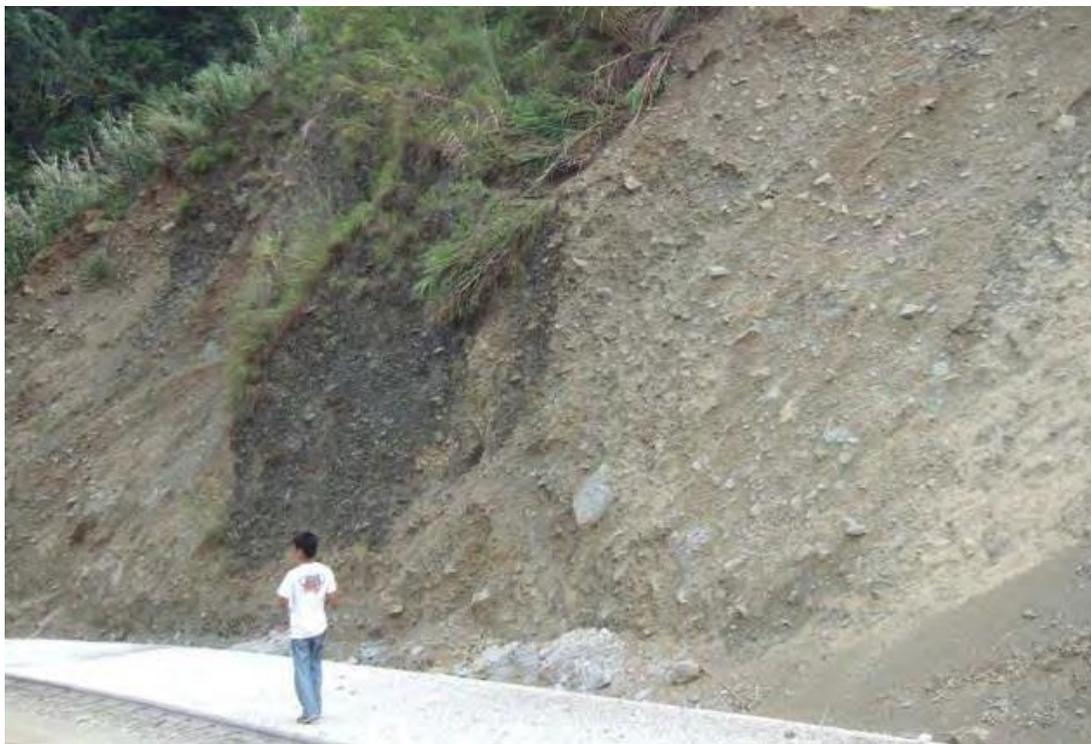
**Photo HS1-1.** Cemented/stiff sand deposit

**Photo HS1-2.** Hammer indentions into the cemented sand deposit

**Photo HS1-3.** Stiff sandy and gravelly deposit

**Photo HS1-4.** Stiff and cemented gravelly deposit (note spring at the left side of the slope)

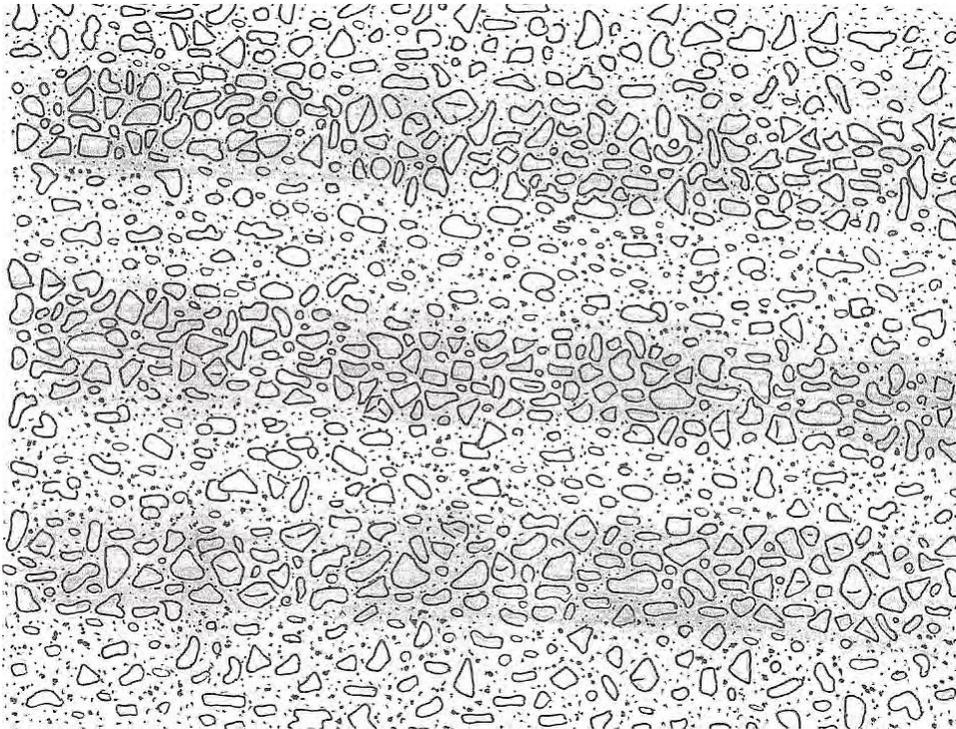
**Figure SS1-1.** Gravelly soil

Note that the SWST is not applicable for gravelly soils.

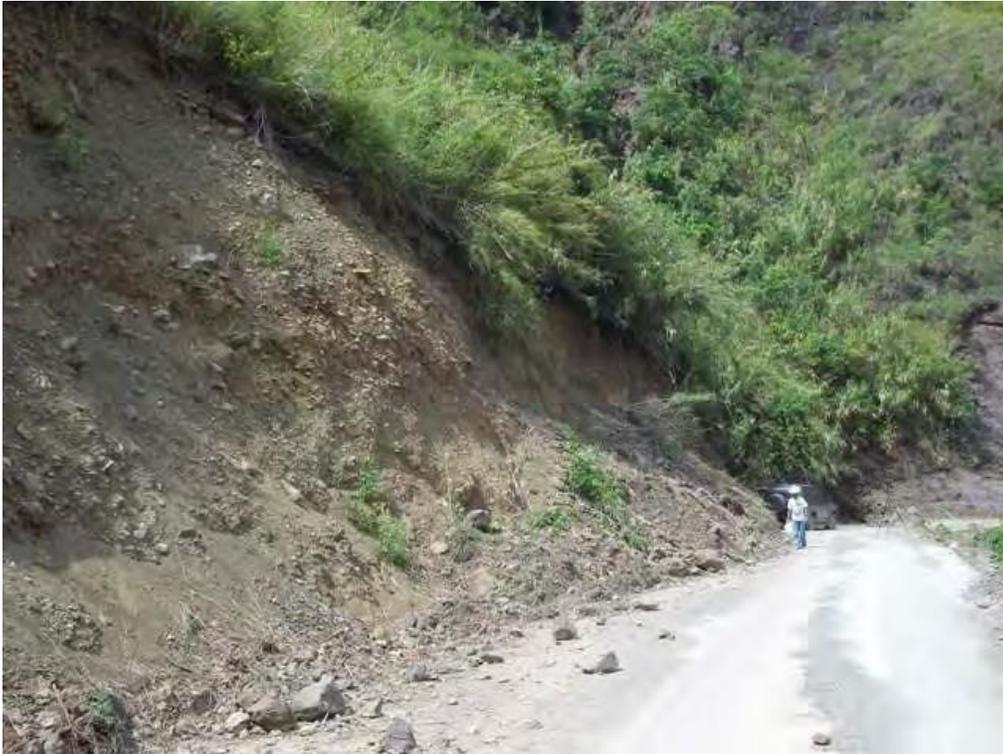
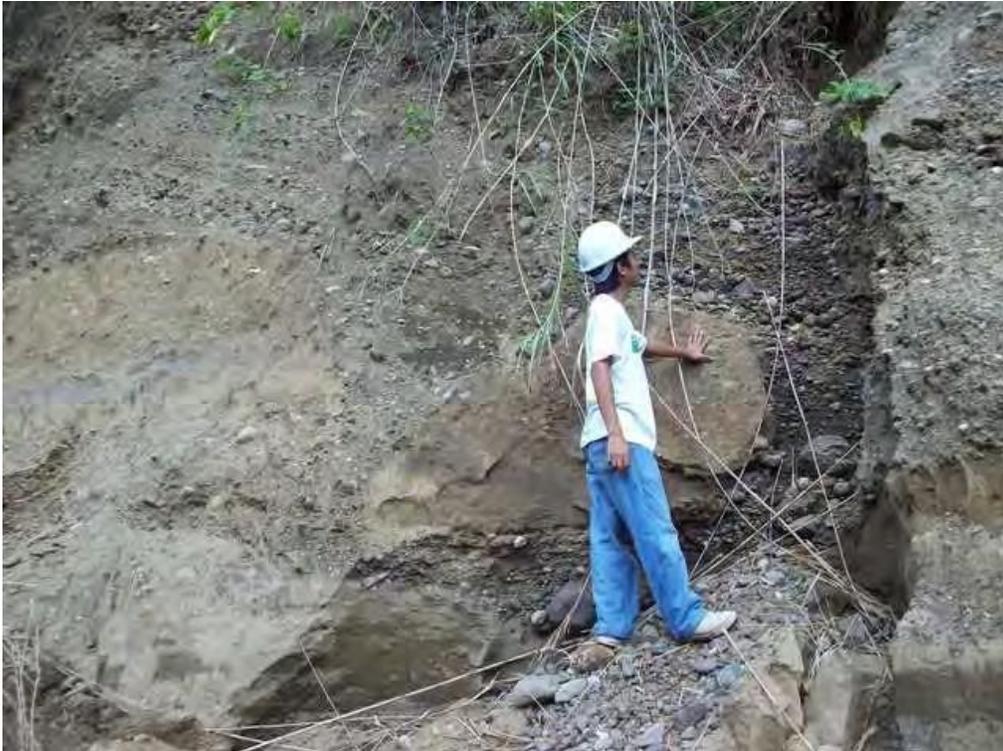
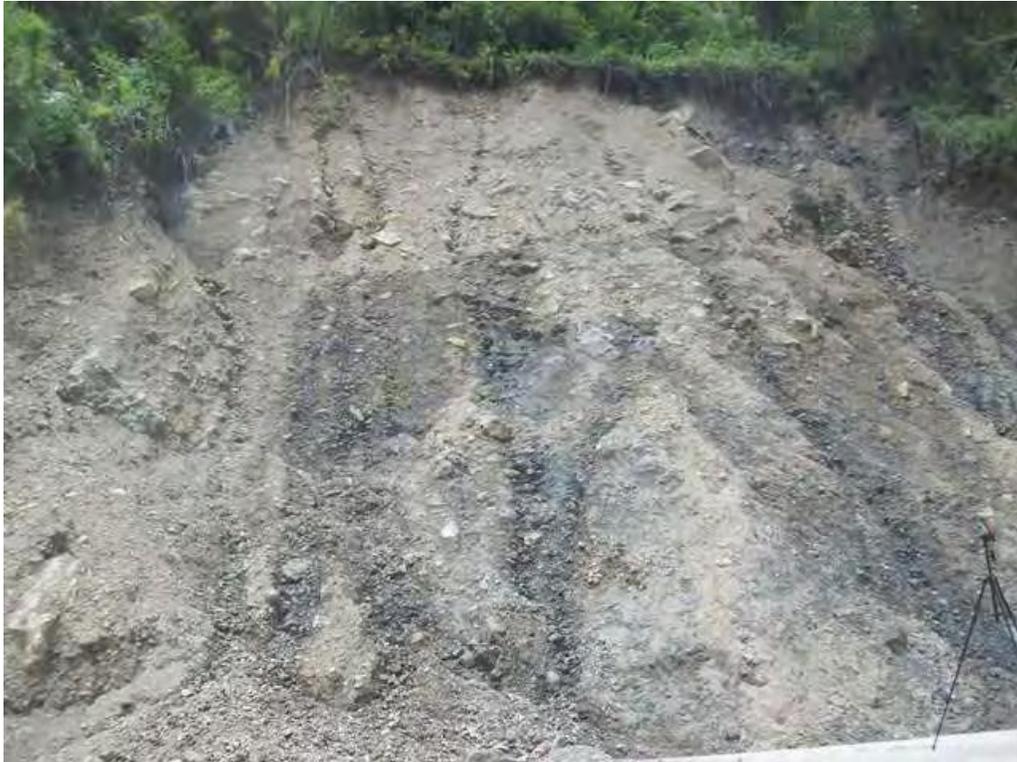
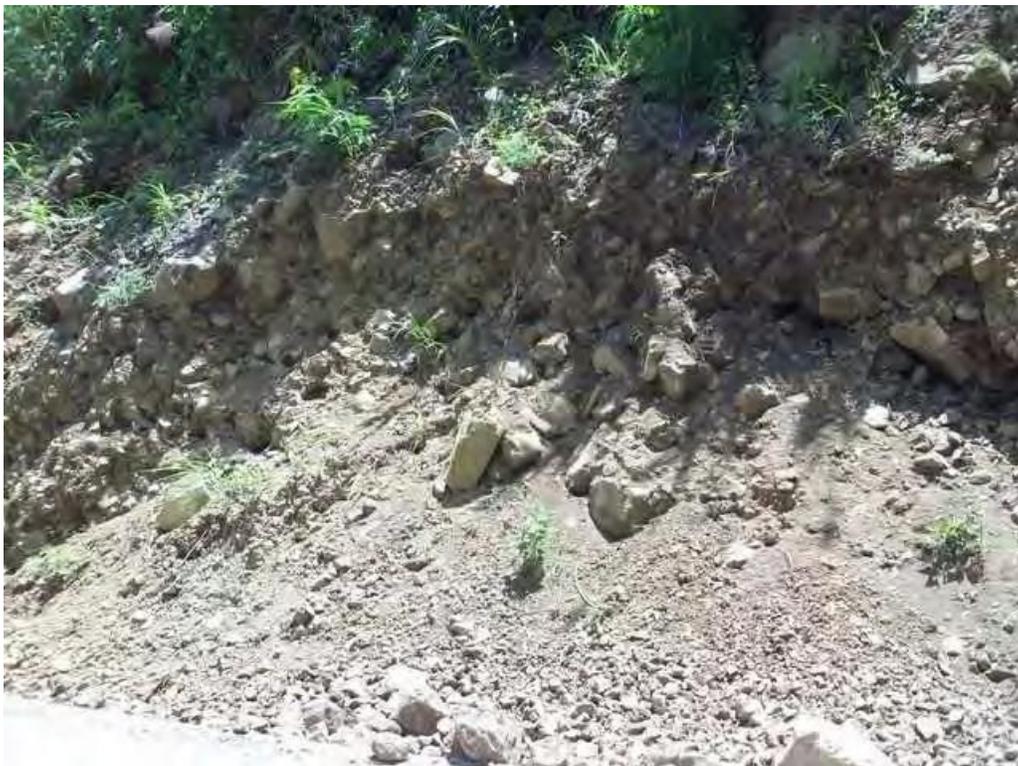
**Photo SS1-1.** Gravelly soil deposit

**Photo SS1-2.** Predominantly gravel deposit

**Photo SS1-3.** A gravelly deposit with springs

**Photo SS1-4.** An eroded gravelly soil deposit

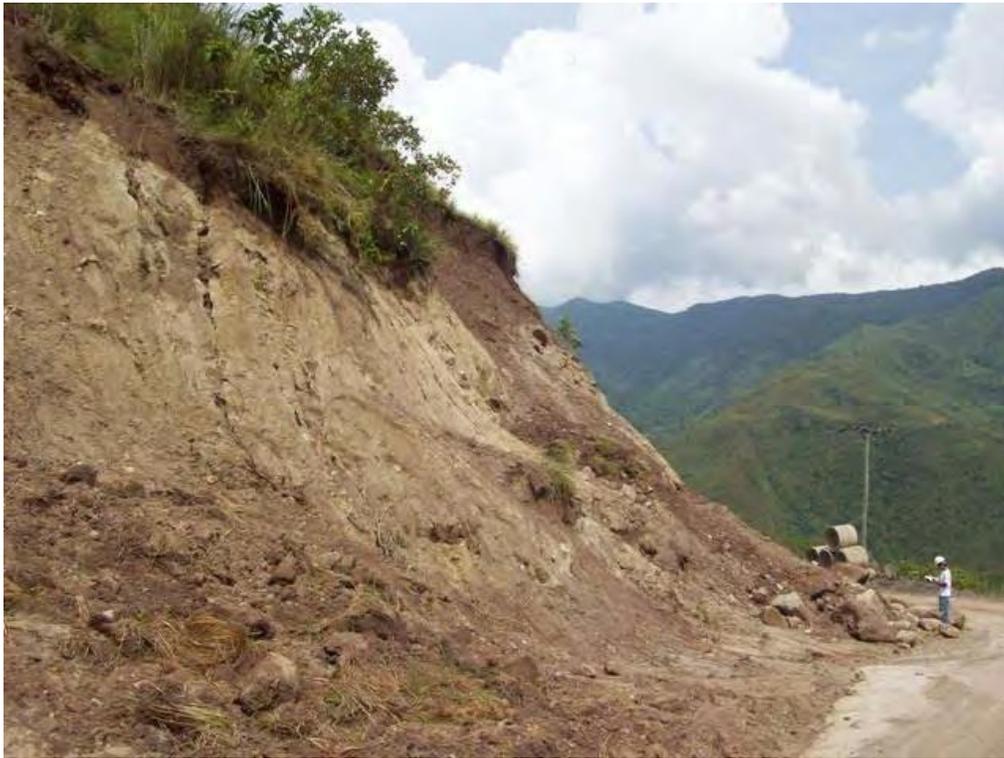
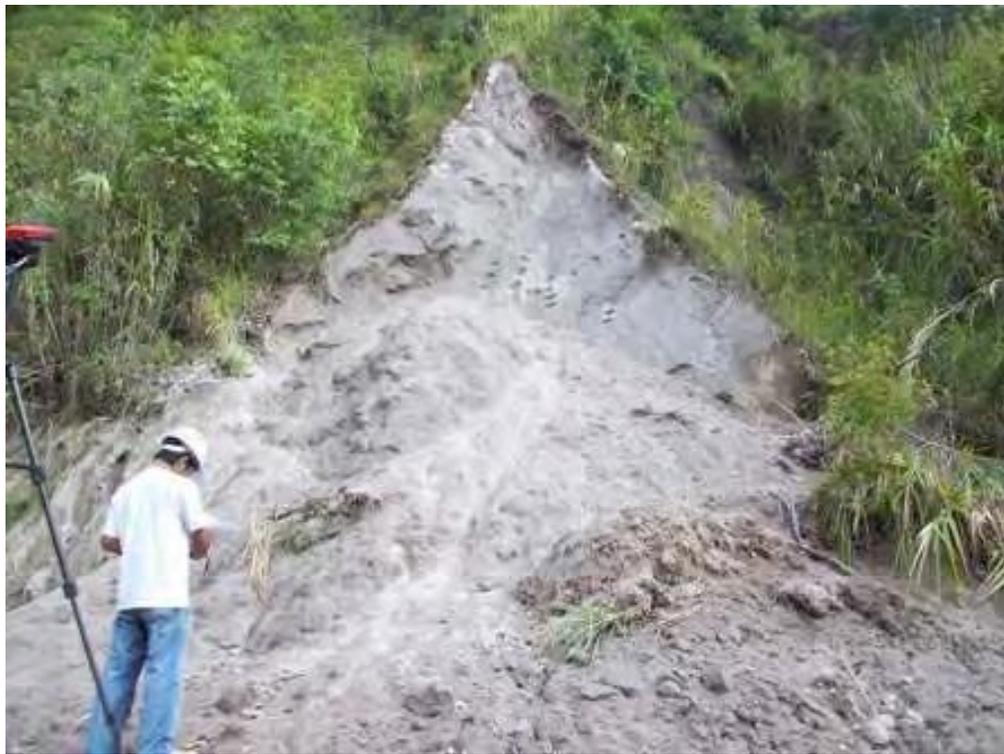
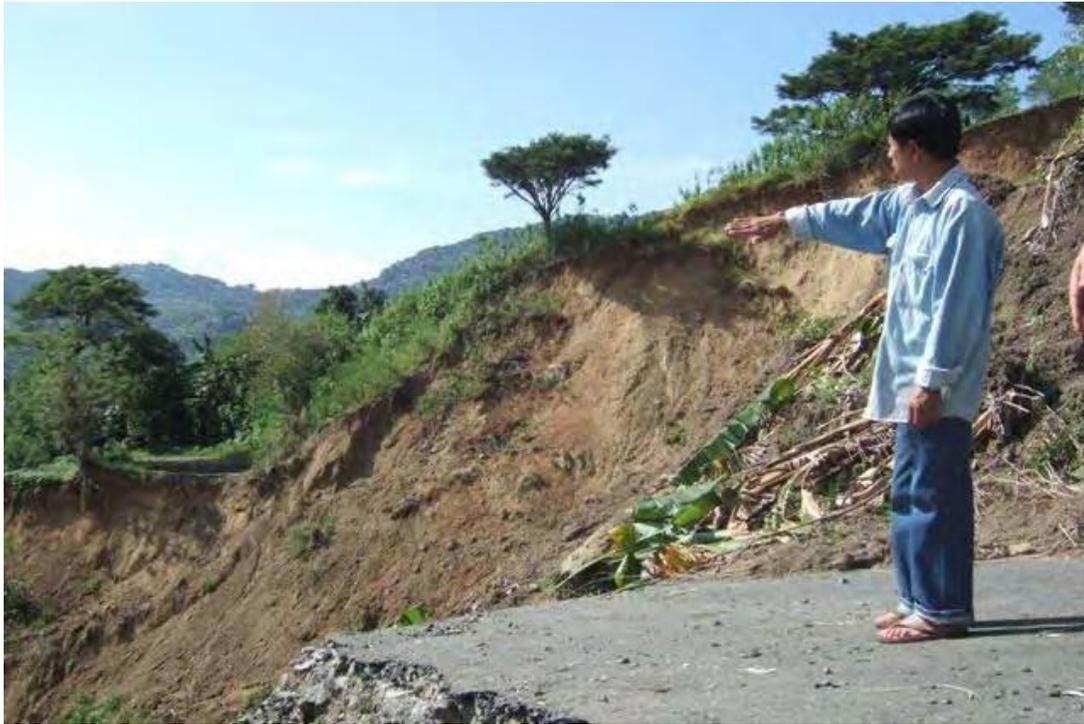
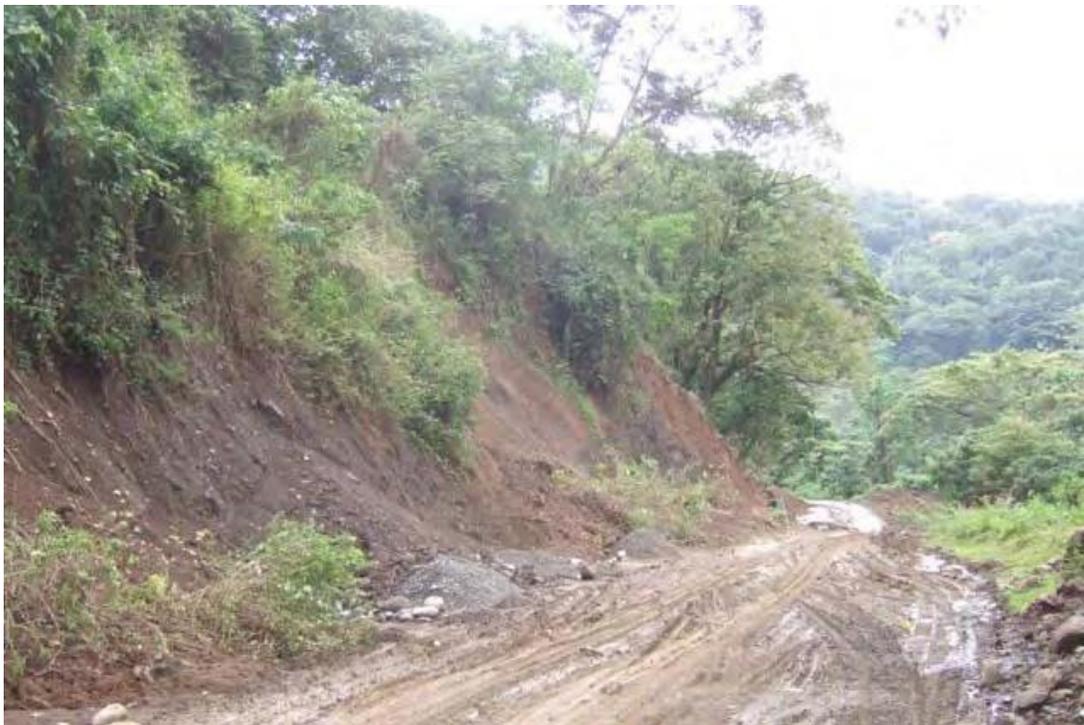
**Photo SS2-1.** Predominantly sand deposit

**Photo SS2-2.** Sand deposit

**Photo SS2-3.** Landslide with sandy material

**Photo SS2-4.** Slope (left) with predominantly sand deposit

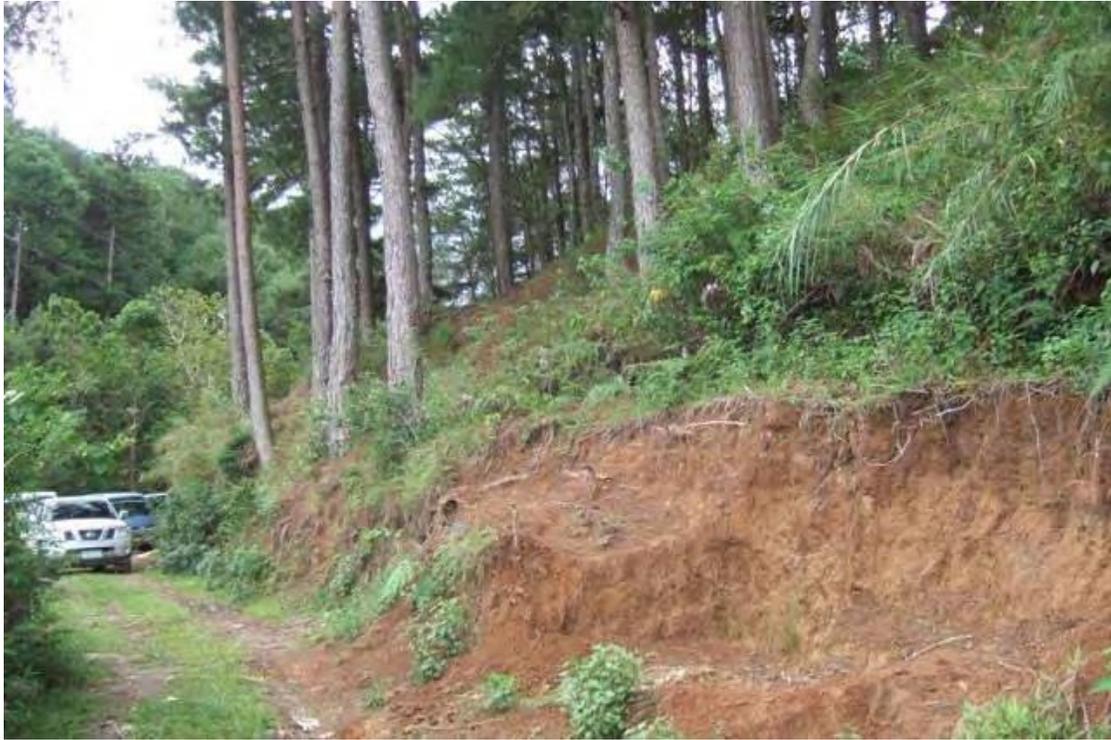
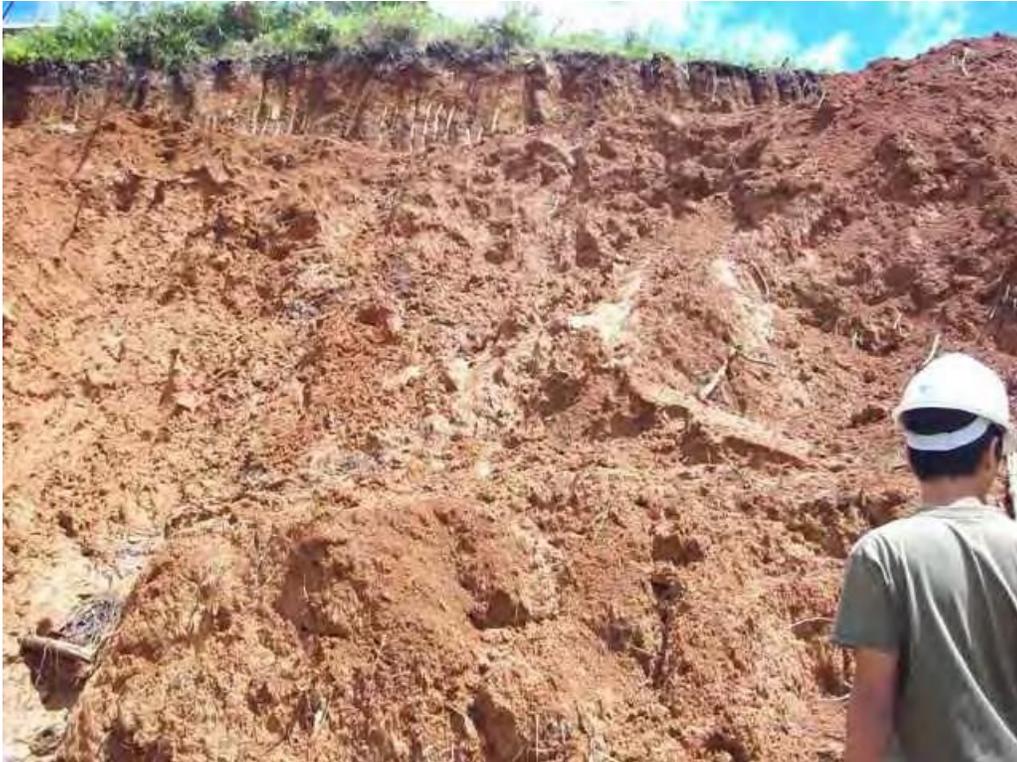
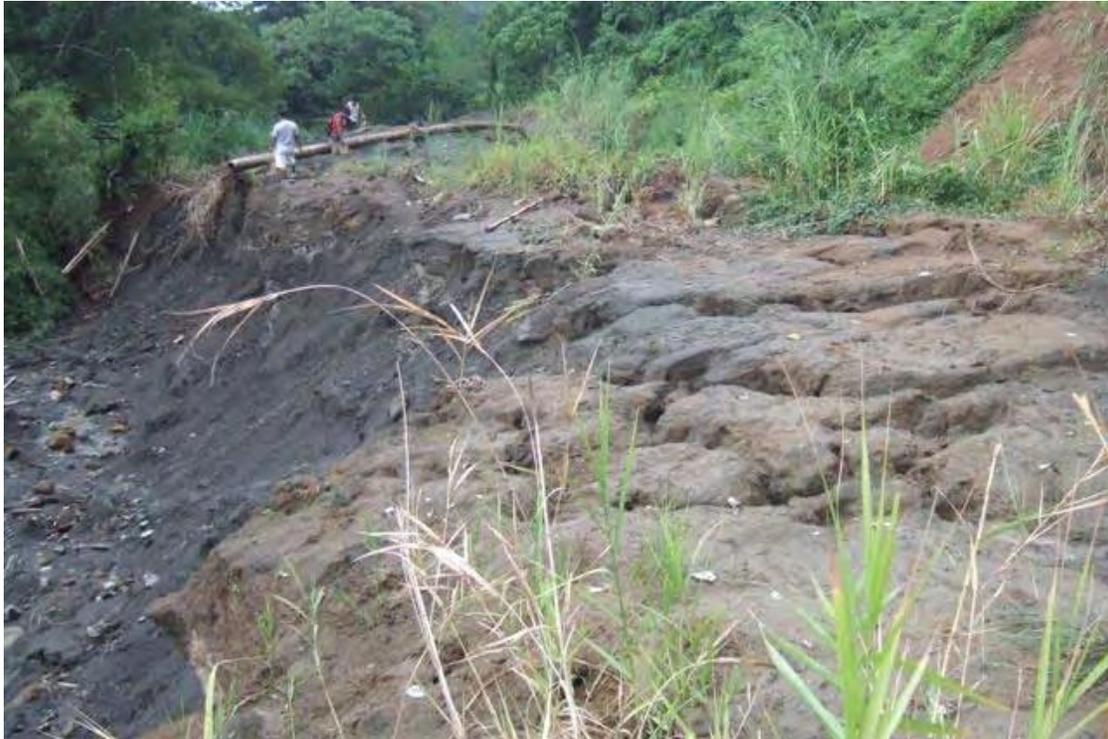
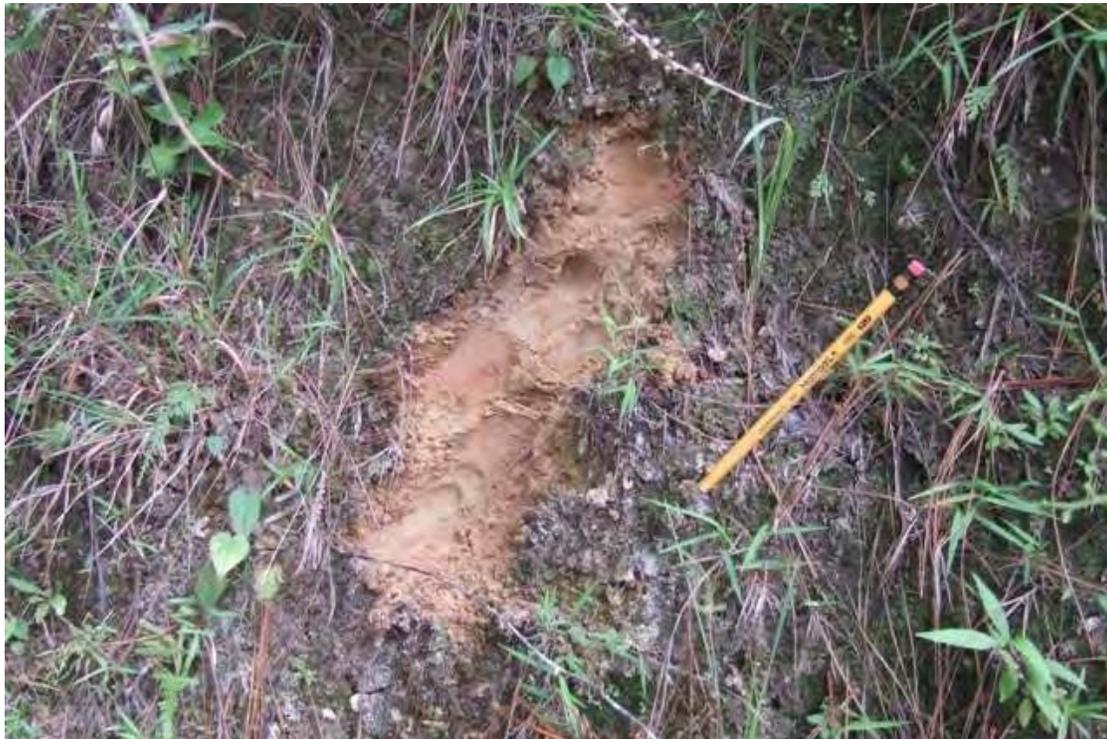
**Photo SS3-1.** Clayey slope with pine trees

**Photo SS3-2.** Excavation into a clayey slope

Photo SS2-3. Silty soil (brownish) and clayey (dark gray) material

Photo SS2-4. Thumb indentation into a clayey material

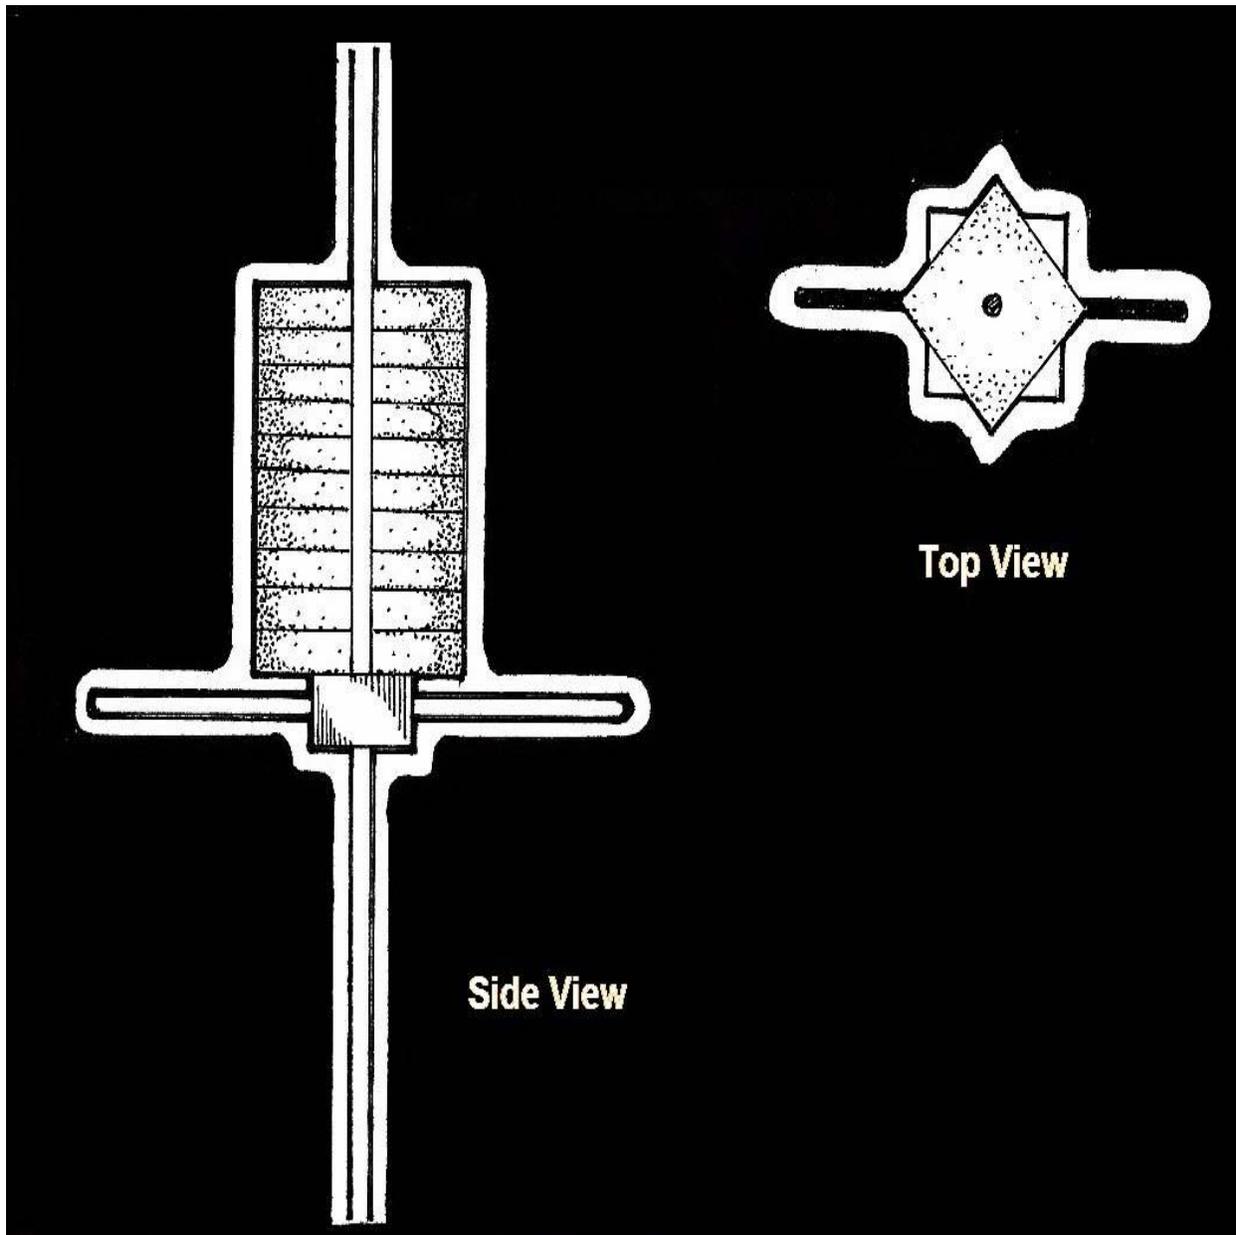
3. The assembly is gradually loaded by placing each of the ten surface weights (WSW) of 10 kg until a total surface weight of 100 kg (0.98KN) is reached. As each load is added, the point starts penetrating the soil. This load is recorded, just as any further loads required to continue penetration.
