# **RAIN-INDUCED LANDSLIDE SUSCEPTIBILITY: A GUIDEBOOK FOR COMMUNITIES & NON-EXPERTS**

**A Guidebook for Communities and Non-Experts**

This guidebook offers a simplified susceptibility assessment of rain-induced, shallow-depth landslides. The assessment procedure takes off from the idea that the strength of the material or structure **S** should always be greater than the applied load or force **L** (**S**>**L**). This concept could be expressed as a factor commonly referred in engineering as Factor of Safety  $F_s = S/L$ , which should always be greater than 1. **Figure 1** below illustrates the concept:

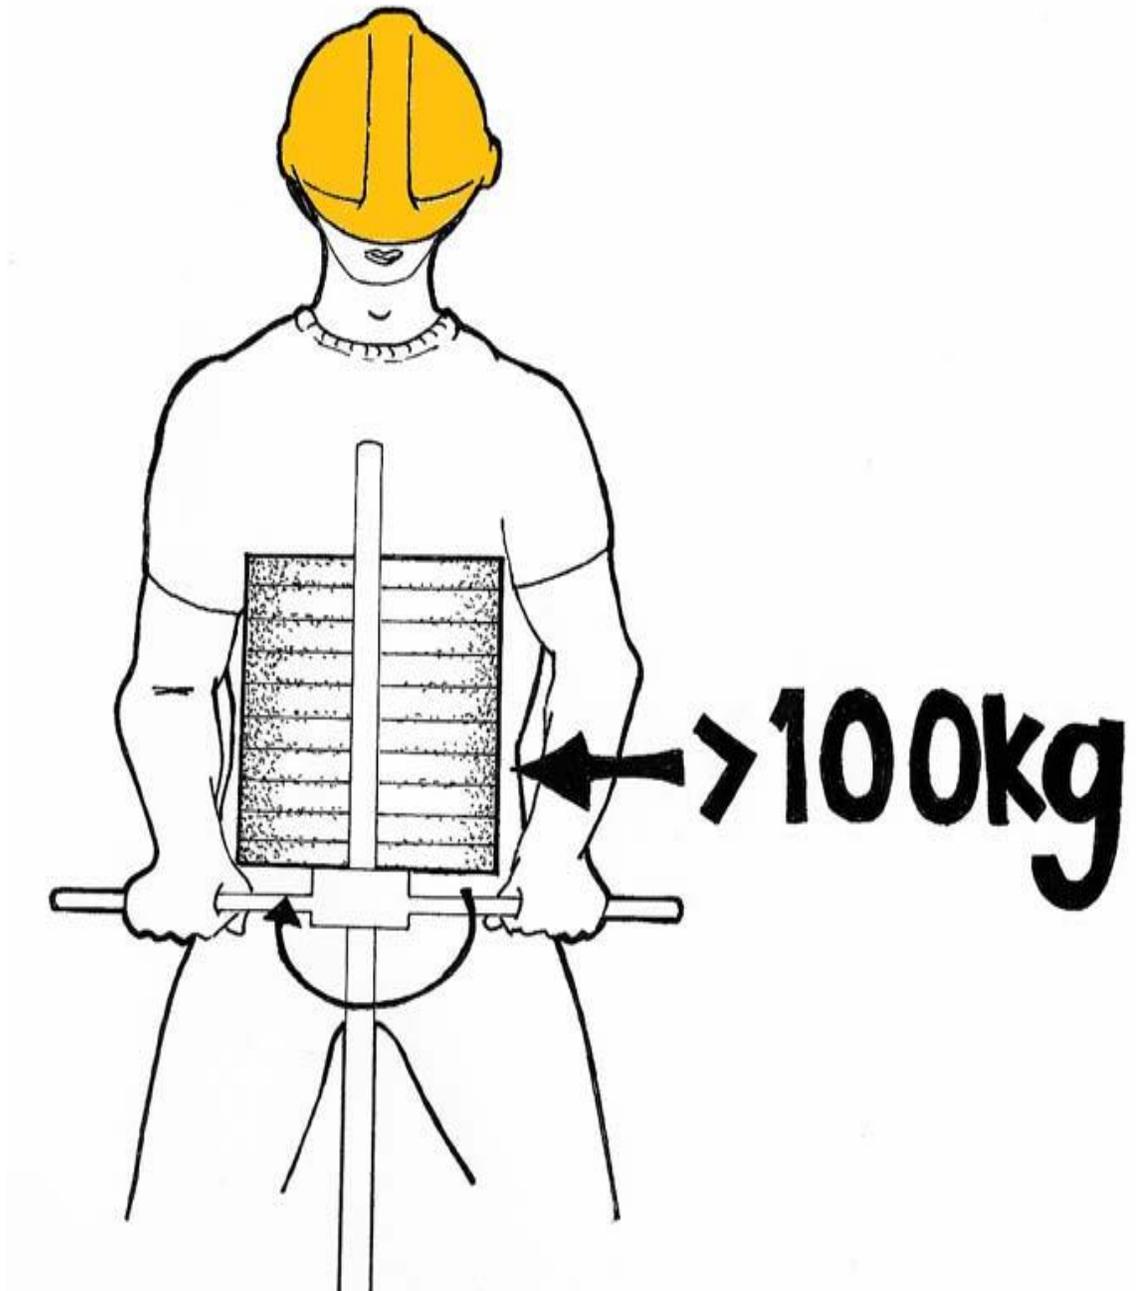
4. As soon as the rod refuses to penetrate under the load of 100 kg, the handle assembly is rotated by hand at half- turns. The handle should not be rotated if the load applied is less than 100 kg.

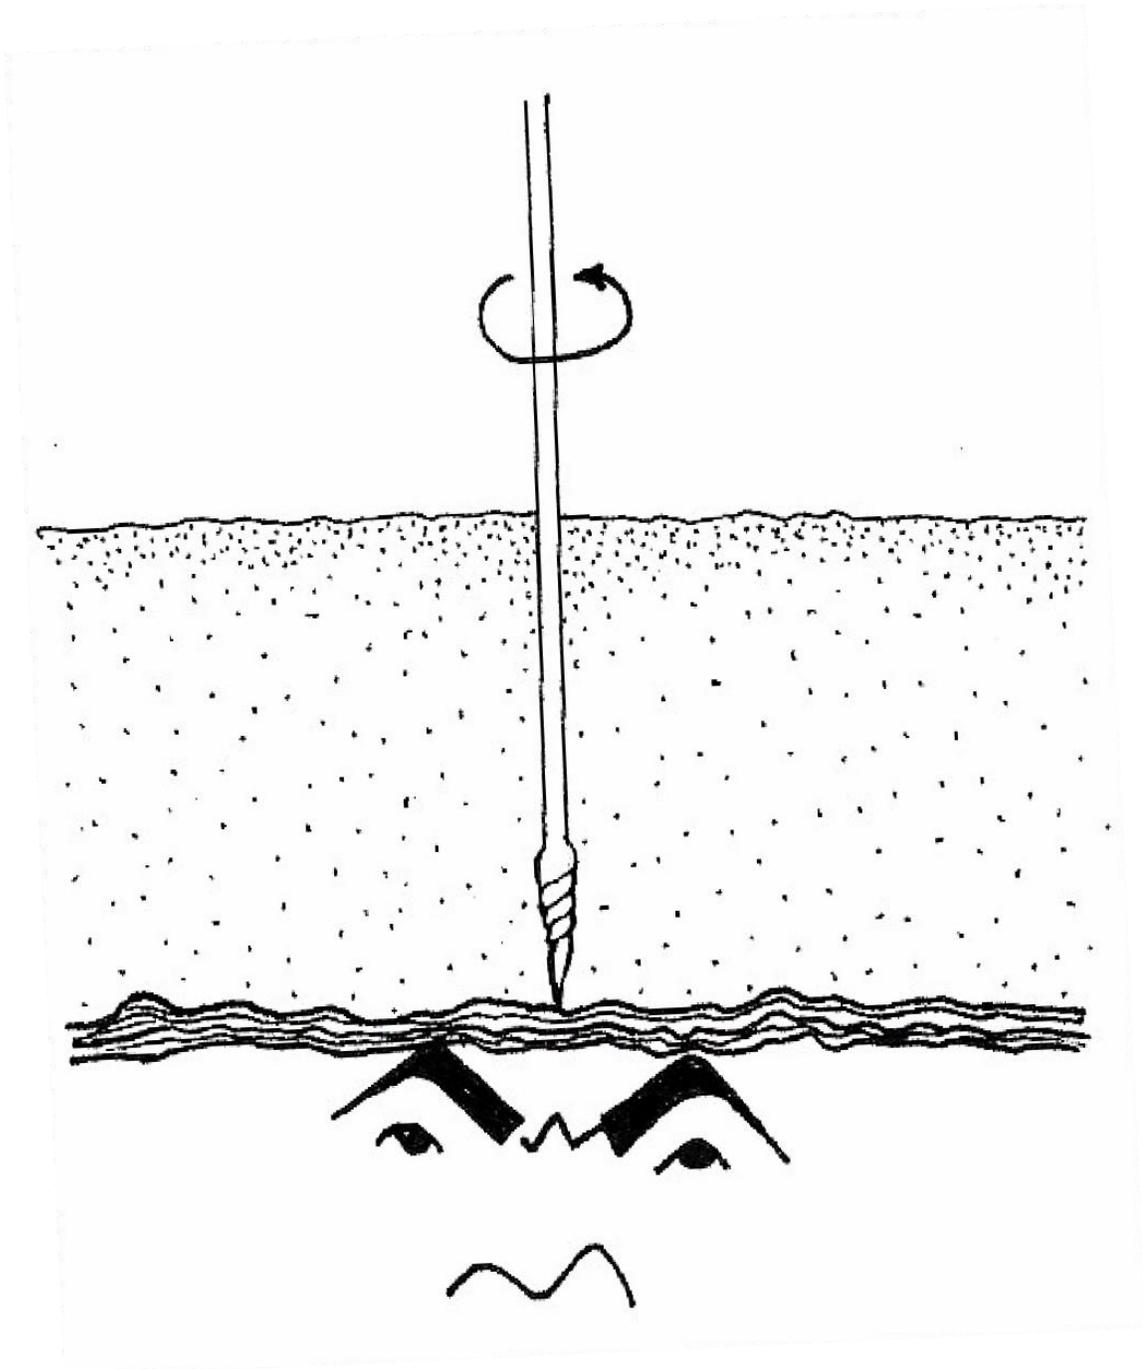
- a. The screw point does not sink any more when rotated;

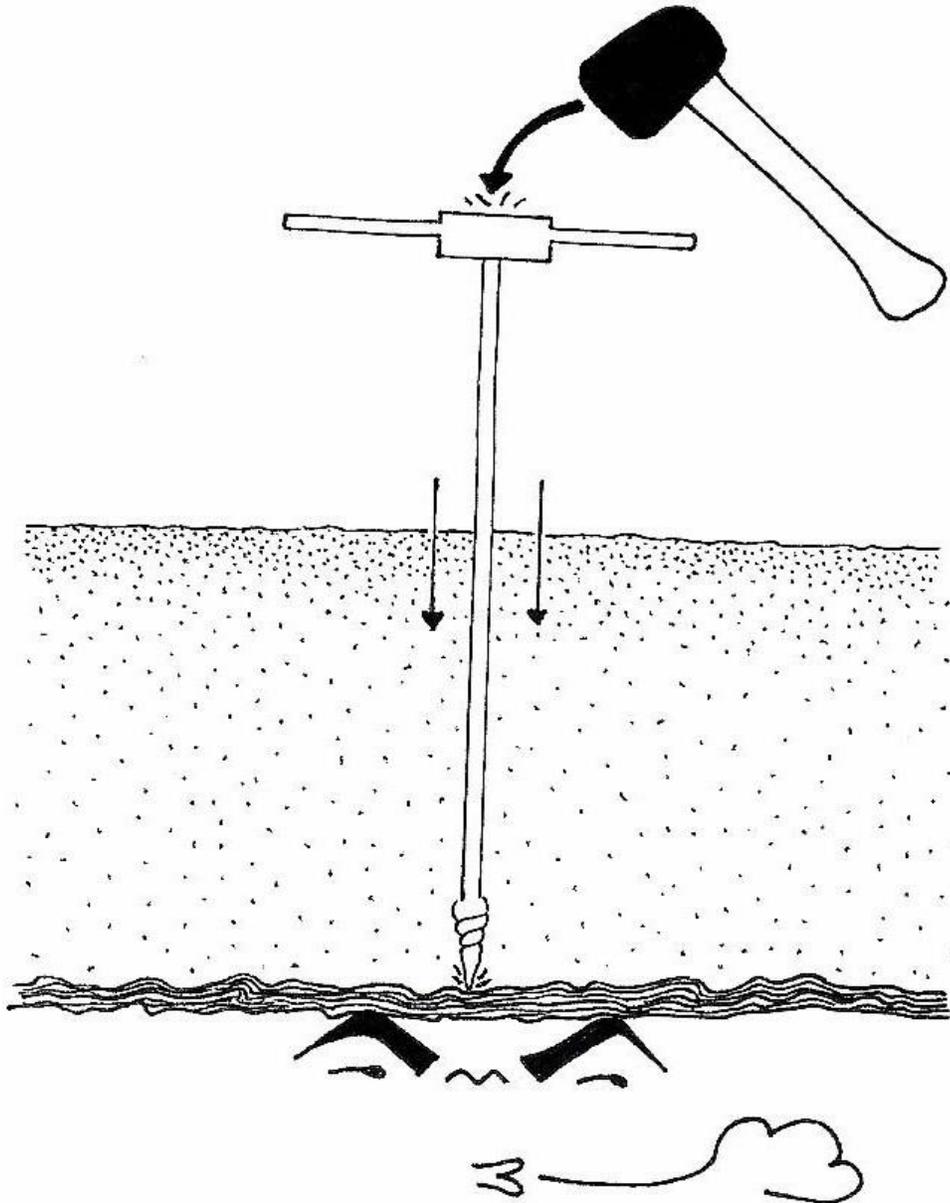
- b. The screw point does not sink even when driven by at least 10 blows of a 3.0 kg sledge hammer.

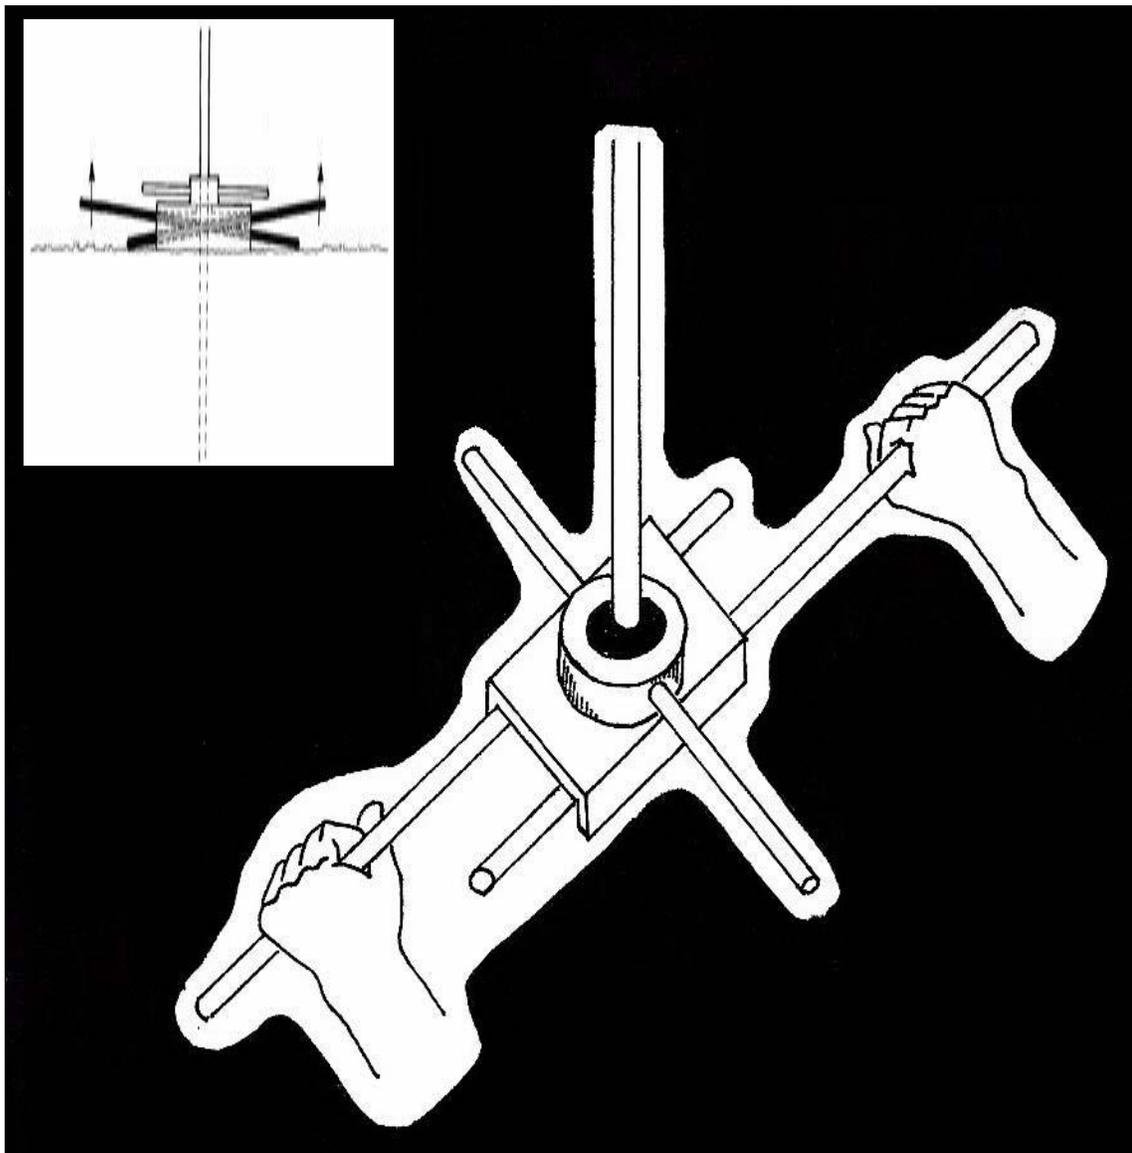
8. Upon termination of the penetration test, unload the weights then remove the series of penetrated rods by positioning two rods on the opposite sides of the bottom plate. Pull upwards the two ends of these rods to create a lever. If the penetrated rod has been loosened, use the handle assembly to pull it further out. If necessary, the position of the handle assembly could be adjusted and relocated as the rod is slowly removed, depending on the difficulty in pulling the rod out.

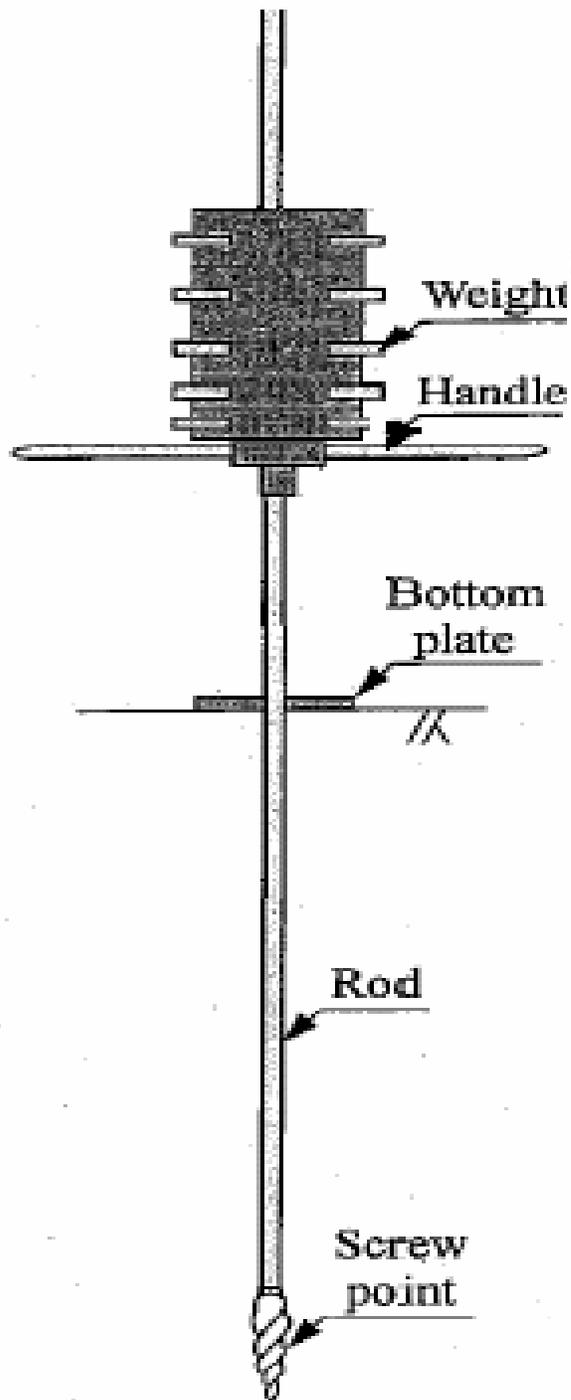
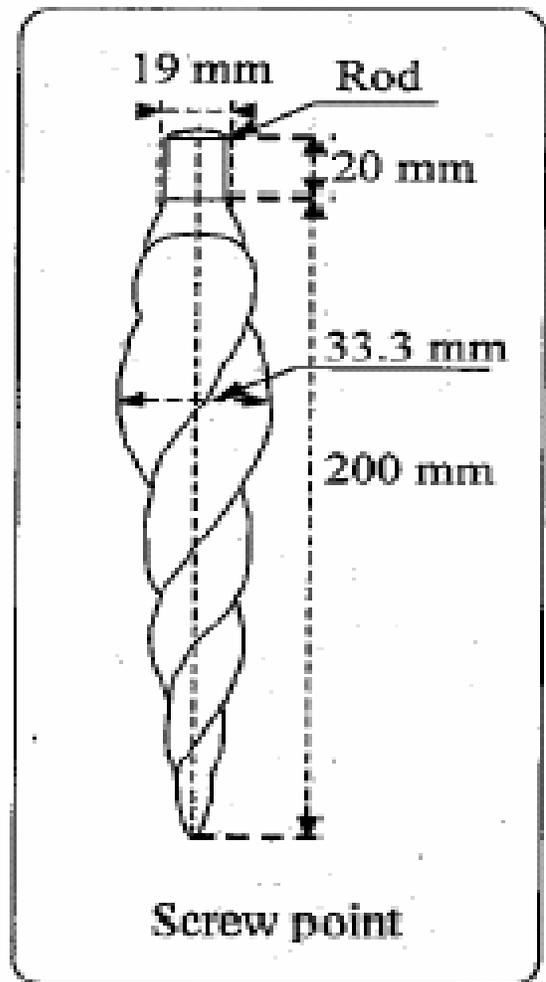
# The Parts of the Swedish Weight Sounding Equipment
